Xxxxxxxxxxxxxx Primary School

MECHANICAL SERVICES
CONDITION REPORT

Contract Title	
Report Title	Mechanical Services Condition Report
Revision	-
Status	Final
Control Date	October 2019

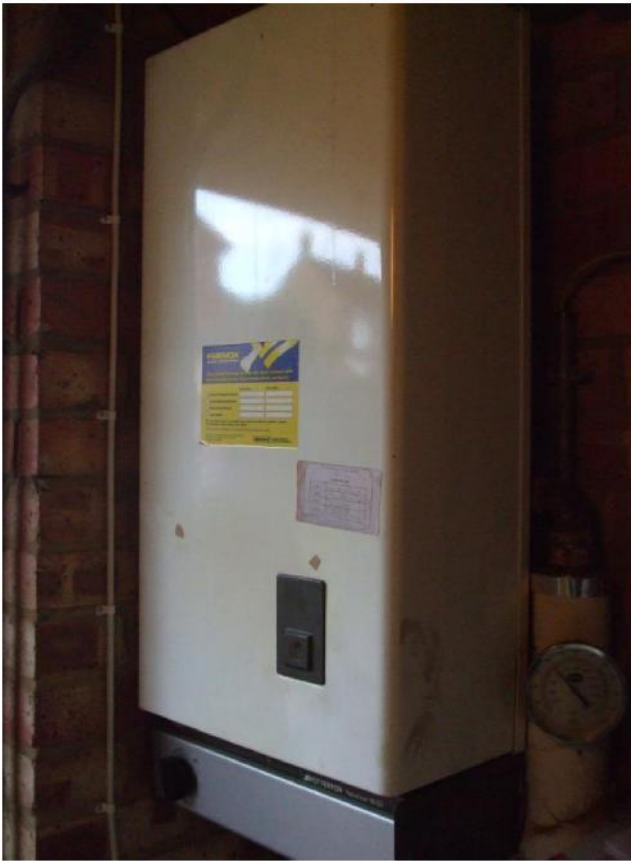
2.1.1. Plant: Block 12 area is serviced by gas fired 1No Potterton Neataheat 16-22 gas fired condensing boiler that was installed 18 years ago and is in poor condition. The boiler provides heating to the underfloor heating system and it passed its economic life with evidence of failure (the indicative economic repair age for such boiler CIBSE Guide M reference is 15 years). Immediate replacement of the boiler for the block 12 is recommended to prevent loss of heat to the area. **Condition / Priority Grade: D1.**

Picture 1- Existing Boiler 12-GF-171 Plantroom (D1)

2.1.1. Plant: Block 12 area is serviced by gas fired 1No Potterton Neataheat 16-22 gas fired condensing boiler that was installed 18 year ago and is in poor condtion. The boiler provides heating to the underfloor heating system. and it passed its economic life. Immediate replacement of the boiler for the block 12 is recommended to prevent long term school closure. **-REPLACE WITH NEW.**

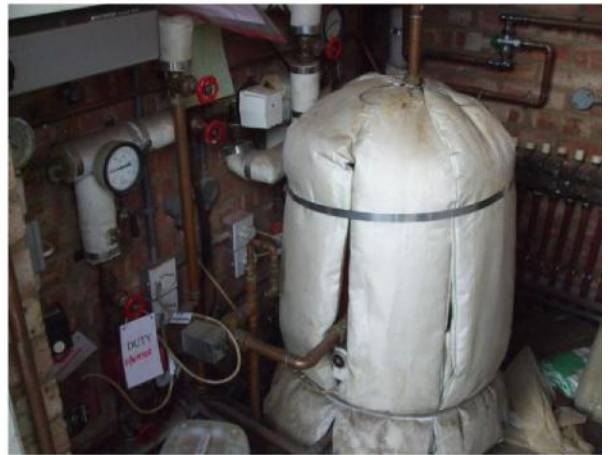
2.1.2. Plant: Block 12 area is serviced to provide hot water by a vented hot water cylinder that was installed 18 years ago. The cylinder provides hot water to all outlets in Block 11. The unit and its insulation is in poor condition and should be replaced with new high efficiency cylinder. **Condition / Priority Grade: D1.**

Picture 2- Existing cylinder 12-GF171 Plantroom D1

2.1.3. Plant: Block 12 area is serviced to provide hot water by a vented hot water cylinder that was installed 18 years ago. The cylinder provides hot water to all outlets in Block 11. The unit and its insulation is in poor condition and should be replaced with new high efficiency cylinder . **- REPLACE WITH NEW.**

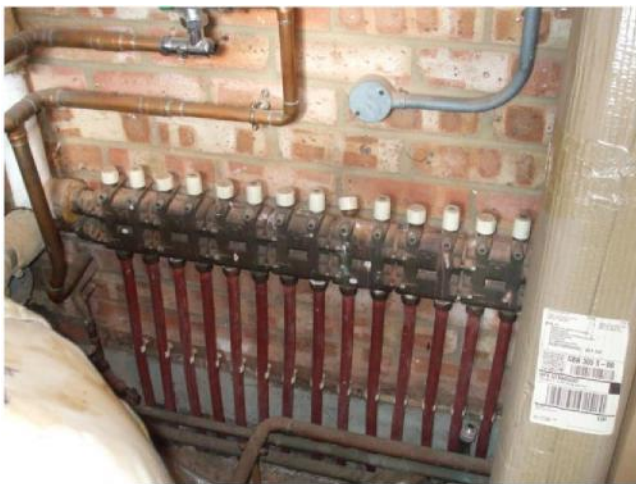
2.1.3. Underfloor Heating system pipework: The underfloor heating system is approximately 25 years old. The school reported no issues with the underfloor heating system operation of manifold and pipework therefore the system shall be retained. **Condition / Priority Grade: B4**

Picture 3- Underfloor heating manifold in 12-GF-164 Plantroom (B4)

2.1.4. Underfloor Heating system pipework: The underfloor heating system is approximately 25 years old. The school reported no issues with the underfloor heating system operation of manifold and pipework therefore the system shall be retained. **-RETAIN.**

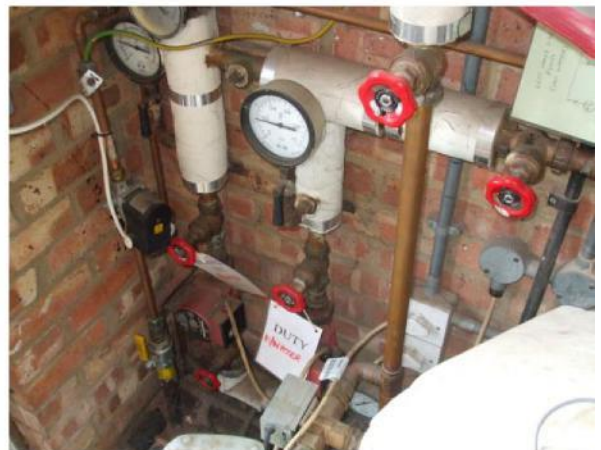
2.1.5. Block 11 existing heating single head primary pumps and secondary single head circulation pump and hot water single head circulation pump in the 12-GF-171 plant room are around 18 years of age. The existing pumps are in poor condition and passed their economic repair age. The pumps are connected directly to the old secondary side of heating pipework. The pumps are under the risk of catastrophic failure and due to no other spare pumps servicing the system such failure may result in school closure. Therefore, it is recommended pumps are replaced with new twin head pumps as soon as possible. **Condition / Priority Grade: D1.**

Picture 4- Grundfos single main heating primary pump (D1) in 12-GF171 Plantroom

2.1.6. Block 11 existing heating single head primary pumps and secondary single head circulation pump and hot water single head circulation pump in the 12-GF-171 plant room are around 18 years of age. The existing pumps are in poor condition and are connected directly to the 38 year old secondary side of heating pipework. The pumps are under the risk of catastrophic failure and due to no other spare pumps servicing the system such failure may result in school closure. Therefore, it is recommended pumps are replaced with new twin head pumps as soon as possible. **-REPLACE WITH NEW.**

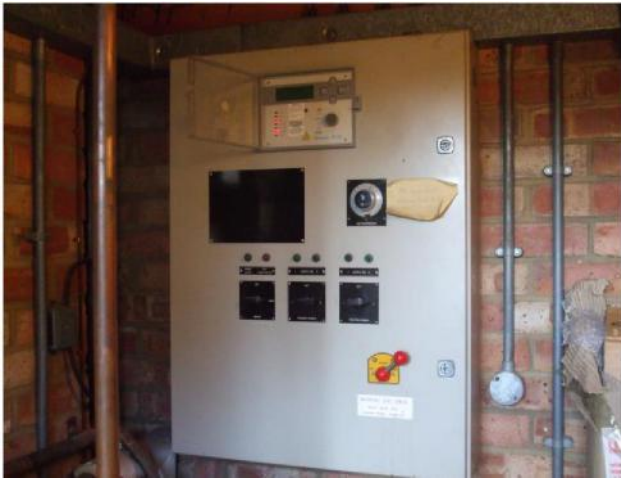
2.1.2. The boiler controls are ineffective; not meeting schools current plant operational needs. The Mechanical Controls and associated ancillaries is estimated to be approximately 18 years old and beyond economic repair age. The school reports that the existing mechanical controls are not reliable to operate and there are operation issues with controlling the plant equipment. Control panel houses the operational on / off switches for the heating boiler, which is a manual timer on the front face of the control panel. It is recommended that the control panel is replaced with new to allow existing plant to be controlled effectively. It is noted that the gas safety detection system sensors are missing from the installation. Therefore, it is recommended additional gas safety system including NG, CO sensors are included within controls to comply with current gas safe regulations. **Condition / Priority Grade: D1.**

Picture 5- Existing control panel to be (12-GF-171) (D1)
Replace with new.

2.1.2. The boiler controls are ineffective; not meeting schools current plant operation needs. The Mechanical Controls and associated ancillaries is estimated to be approximately 18 years old and reaching the end of economic repair age. It is recommended that the control panel is replaced with new to allow existing plant to be controlled effectively. **- REPLACE WITH NEW .**

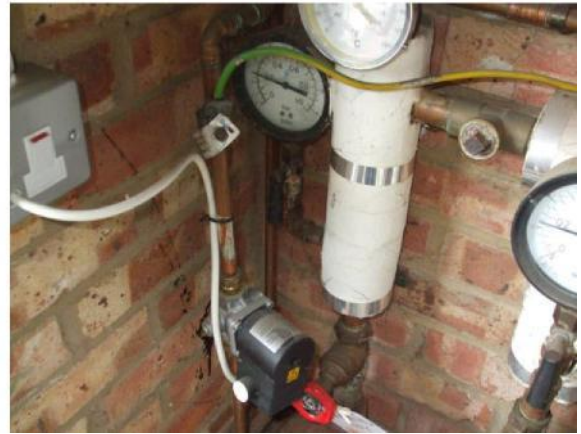
Picture 6- Gas solenoid valve to be replaced with new in 12-GF-171 Plantroom (D1).

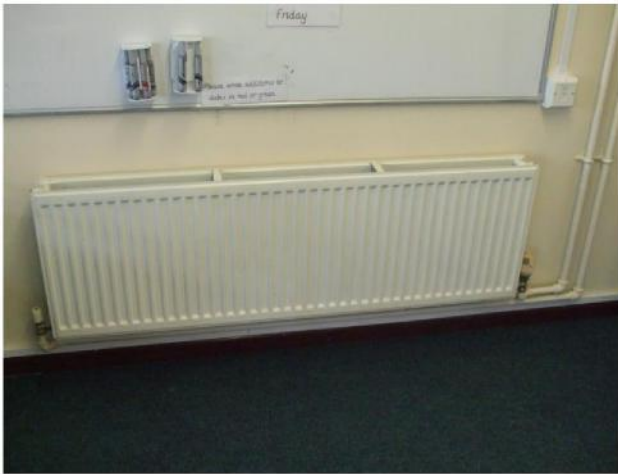
1.2.1 The existing two pipe low temperature hot water heating system pipework is the original steel pipework that was installed when the school was built approximately 60 years ago and it runs exposed at high levels throughout the site from the Plantroom Block 11 to the mixture of radiators and fan convectors within Block 11 ref. 1100330125. The heating system is beyond economical repair age (exceeded CIBSE Guide M indicative life expectancy of 35 years) and it is under a high risk of failure due to the age of the pipework. The heating pipework is serviced by one zone and is missing thermal insulation in most areas that contributes to inefficiency and imbalanced heating distribution and overheating issues that was reported by the member of staff. However, the pipework appears to be in satisfactory condition with no evidence of leaks and no issues were raised by the site manager. Replacement of the heating system pipework for the block 11 is recommended within next two years to prevent long term school closure due to age of the pipework. **Condition / Priority Grade: D1**

Picture 7- Block 11 Radiator with TRV in satisfactory Condition (B4). Pipework to be replaced with new (D1)

1.2.1 The existing two pipe low temperature hot water heating system pipework is the original steel pipework that was installed when the school was built approximately 60 years ago and it runs exposed at high level throughout the site from the Plantroom Block 11 to the mixture of radiators and fan convectors within Block 11 ref. 1100330125. The heating system is beyond economical repair age (exceeded CIBSE Guide M indicative life expectancy of 35 years) and it is under a high risk of failure due to the age of the pipework. The heating pipework is serviced by one zone and is missing thermal insulation in most areas that contributes to inefficiency and imbalanced heating distribution and overheating issue that was reported by the member of staff. This appears to be in good condition with no evidence of leaks and no issues were raised by the site manager. Immediate replacement of the heating system pipework for the block 11 is recommended to prevent long term school closure. – **REPLACE WITH NEW.**

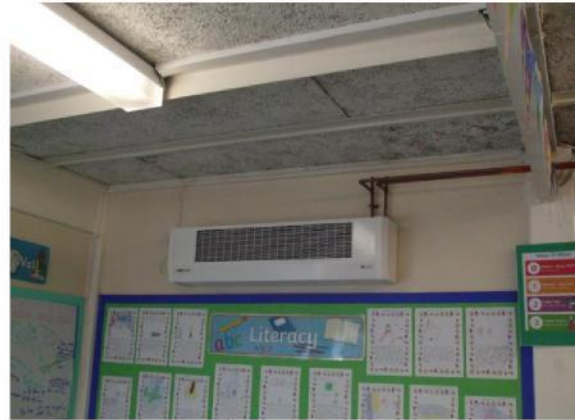
Picture 8- new fan convector (typical classroom) in Block 11 with old heating uninsulated pipework to be replaced with new (D1).

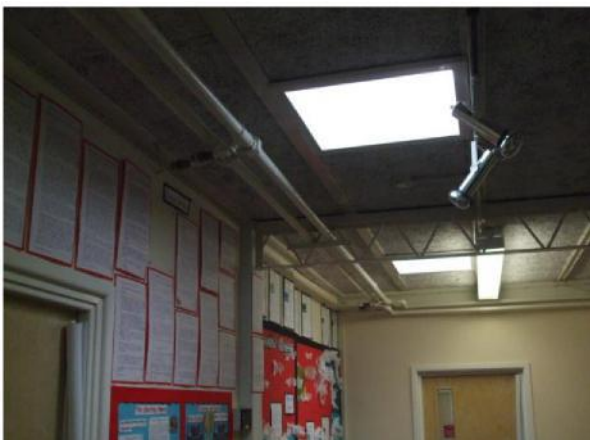
Picture 9- Block 11 Uninsulated old heating pipework (D1)

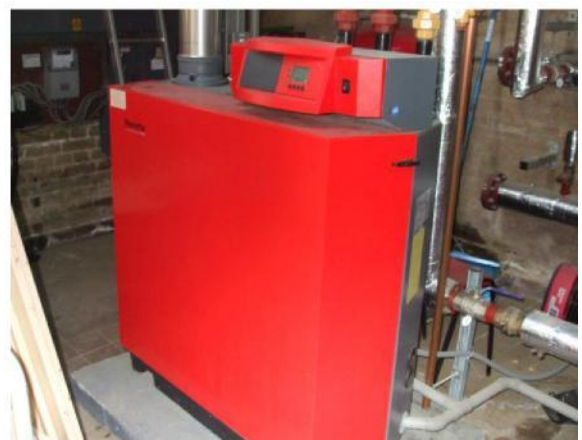
1.1.1. The school Block 11 heating system is serviced by by 2No Remeha 210 Gas Eco Pro gas fired condensing boilers with collectively 420kW heating output located in Block 11 Plantroom. The boilers are nearing 6 years old and are considered to be in good condition and in good repair. The maintenance records indicate the boilers are in good condition. It is recommended the heating plant is retained. **Condition / (Priority: A4)**

Picture 10- Boiler No 1 in Block 11 plantroom in good condition 11-GF-155 (A4)

1.1.1. The school Block 11 heating system is serviced by by 2No Remeha 210 Gas Echo Pro gas fired boilers with 420kW heating output located in Block 11 Plantroom. The boiler is nearing 6 years old and is within its economic life. – RETAIN.

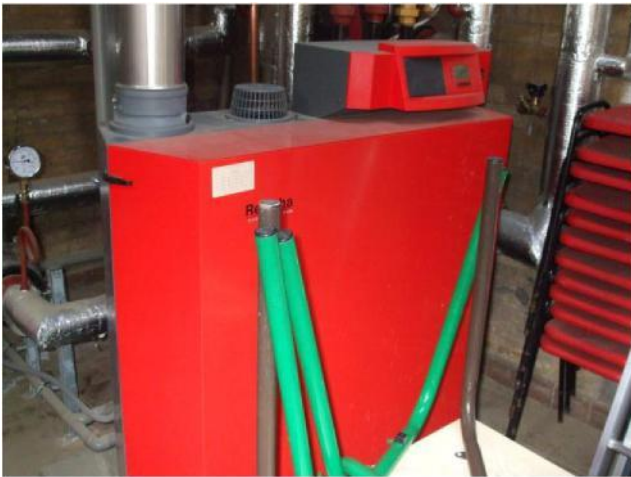
Picture 11- Boiler No 2 in Block 11 plantroom
In good condition (A4) 11-GF-155

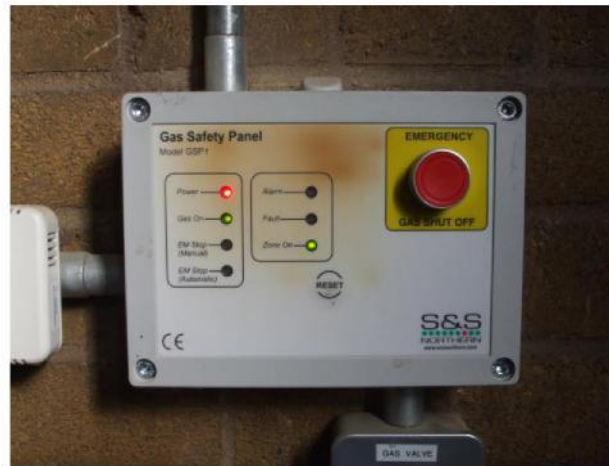
Picture 12- Existing gas safety control panel
11 plantroom 11-GF-155 to be replaced (B2)

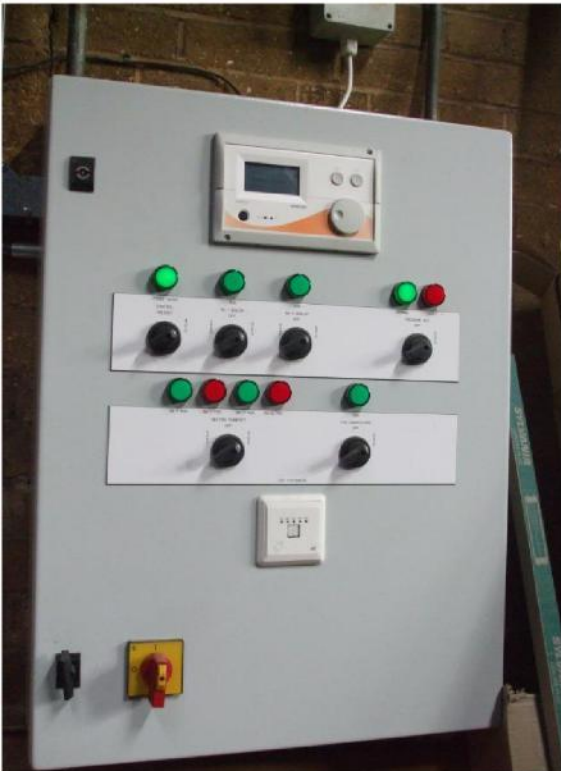
1.1.4. The existing heating system controls were replaced in recent years by the school in the Block 11 plantroom (11-GF-155). The visual inspection indicates that the Mechanical Control Panel and associated ancillaries is estimated to be approximately 8 years old and is in good condition. Control panel houses the operational on / off switches for the heating boiler, heating and domestic water pumps only. The controller has a manual timer and temperature controller on the front face of the control panel. It is recommended that the control panel is modified to allow new plant to be controlled effectively. **Condition / Priority Grade: B1**

Picture 13- Existing mechanical control panel
in Block 11 plantroom 11-GF-155 in good condition (B4)

1.1.4. The existing heating system controls were replaced in recent years by the school in the Block 11 plantroom (11-GF-155). The visual inspection indicates that the Mechanical Control Panel and associated ancillaries is estimated to be approximately 8 years old and is in good condition. – RETAIN.

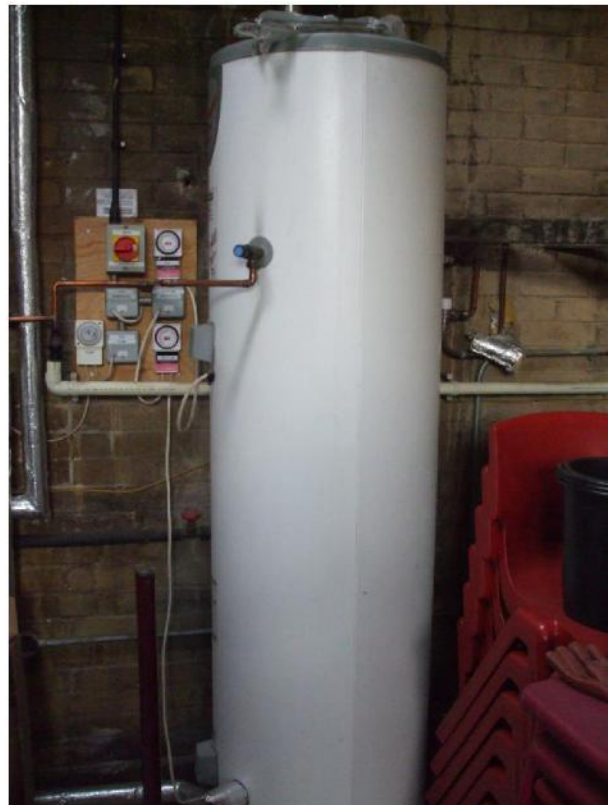
1.1.2. Domestic hot water to the kitchen is provided by 1 off mains fed Megaflo direct electrical hot water cylinder serviced by electrical immersion heaters located in Block 11 plantroom. The cylinder is 6 years old within its economical repair age. Therefore, it is recommended the unit is retained. **Condition / Priority Grade: A4**

Picture 14- Block 11 cylinder to be retained in
plantroom 11-GF-155 (B2).

1.1.2. Domestic hot water to the kitchen is provided by 1No mains fed Megaflo direct hot water cylinder serviced by electrical immersion heaters located in Block 11 plantroom. The cylinder is 6 years old within its economical repair age. – RETAIN.
