Condition Survey Report of Flat Roof Areas and Windows

[Redacted] School

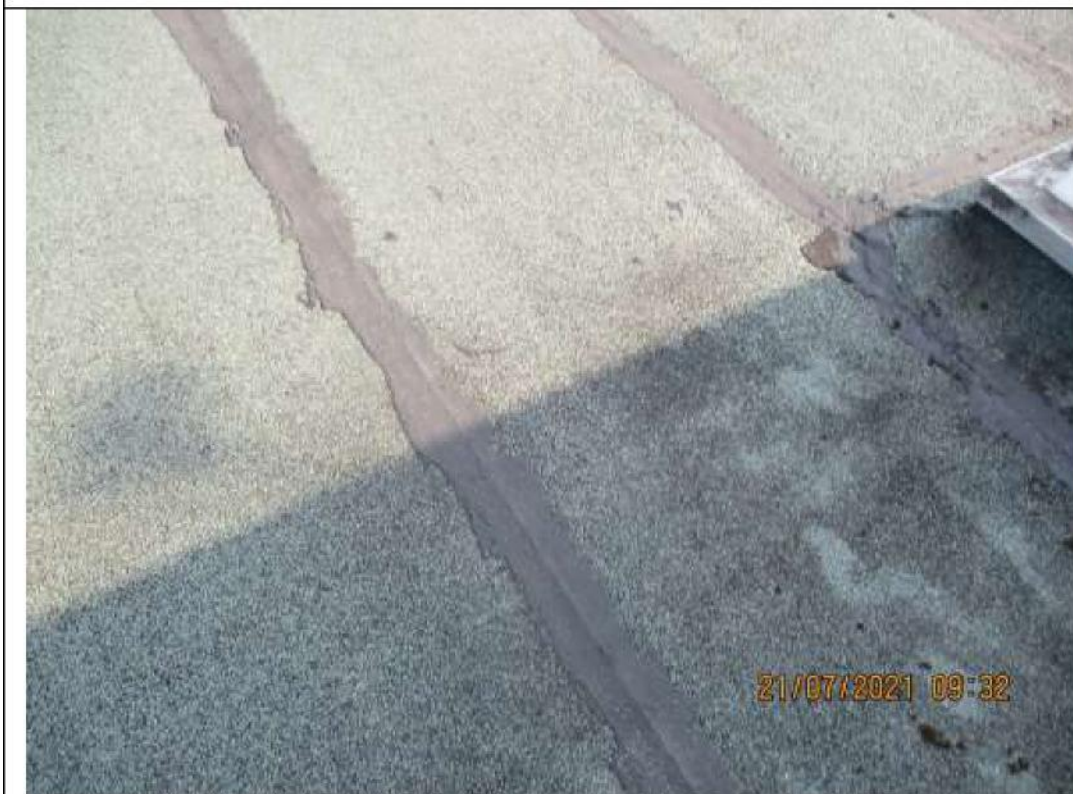
4) Temporary patch repairs to roof coverings.

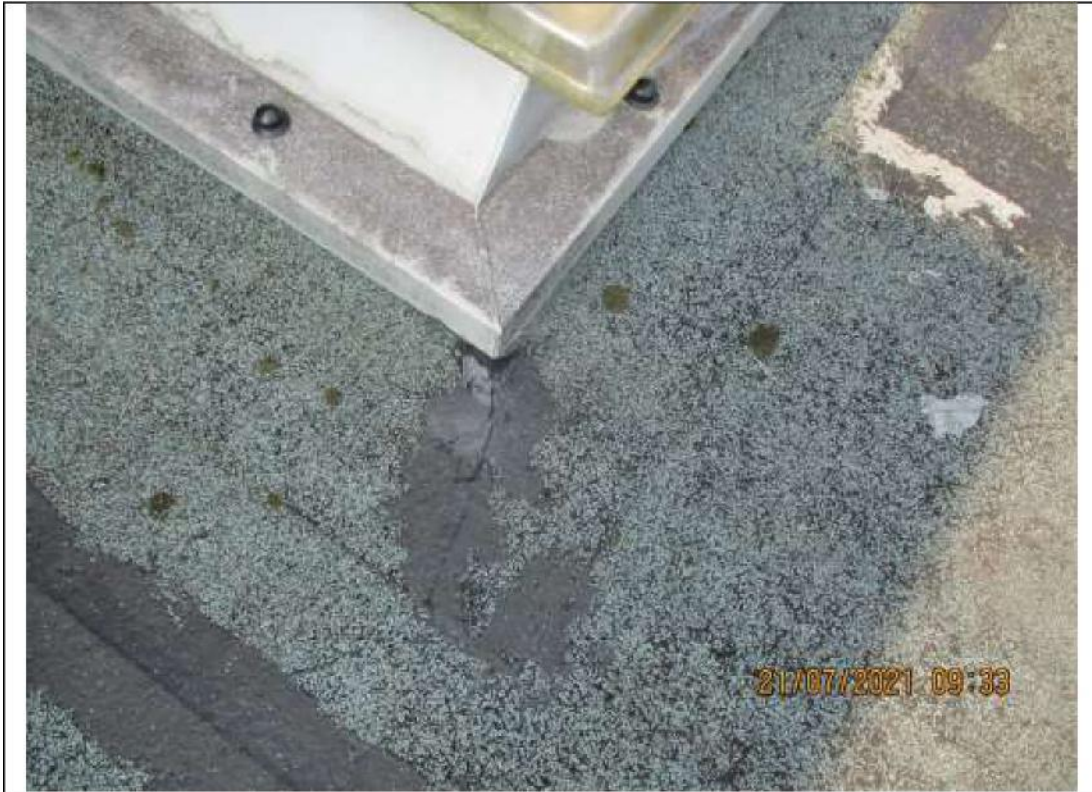
5) Patch repairs to upstand detail to roof light.

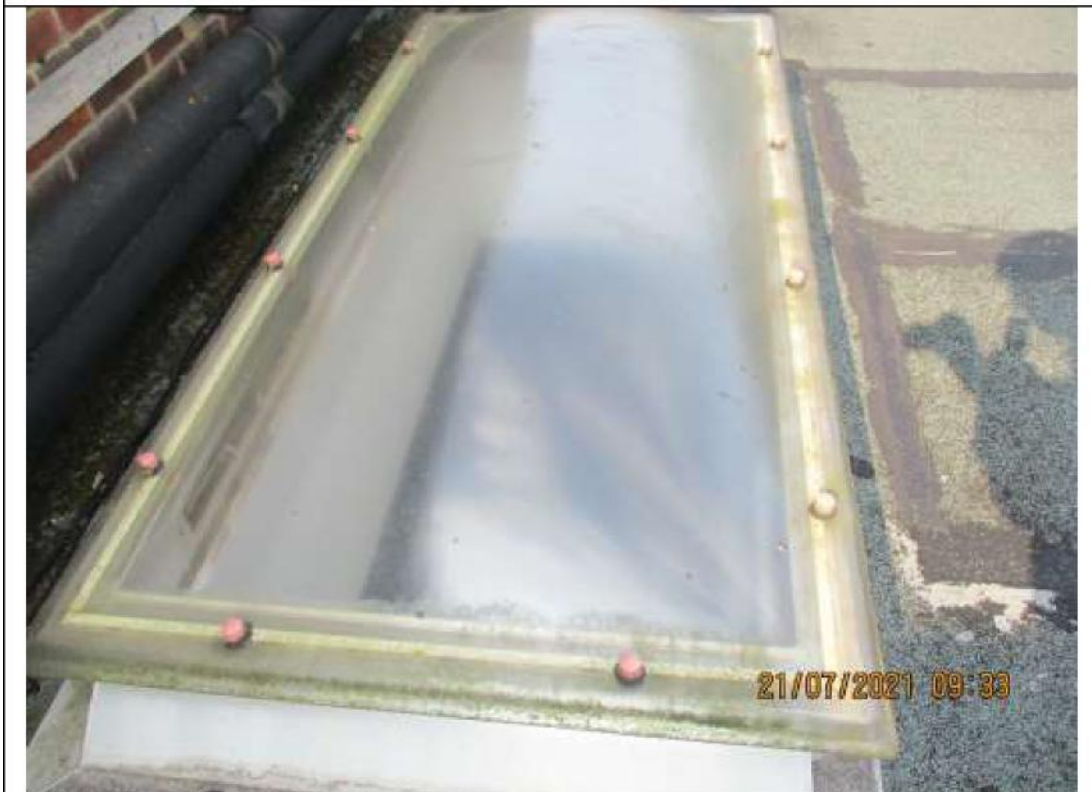
6) Typical roof light.

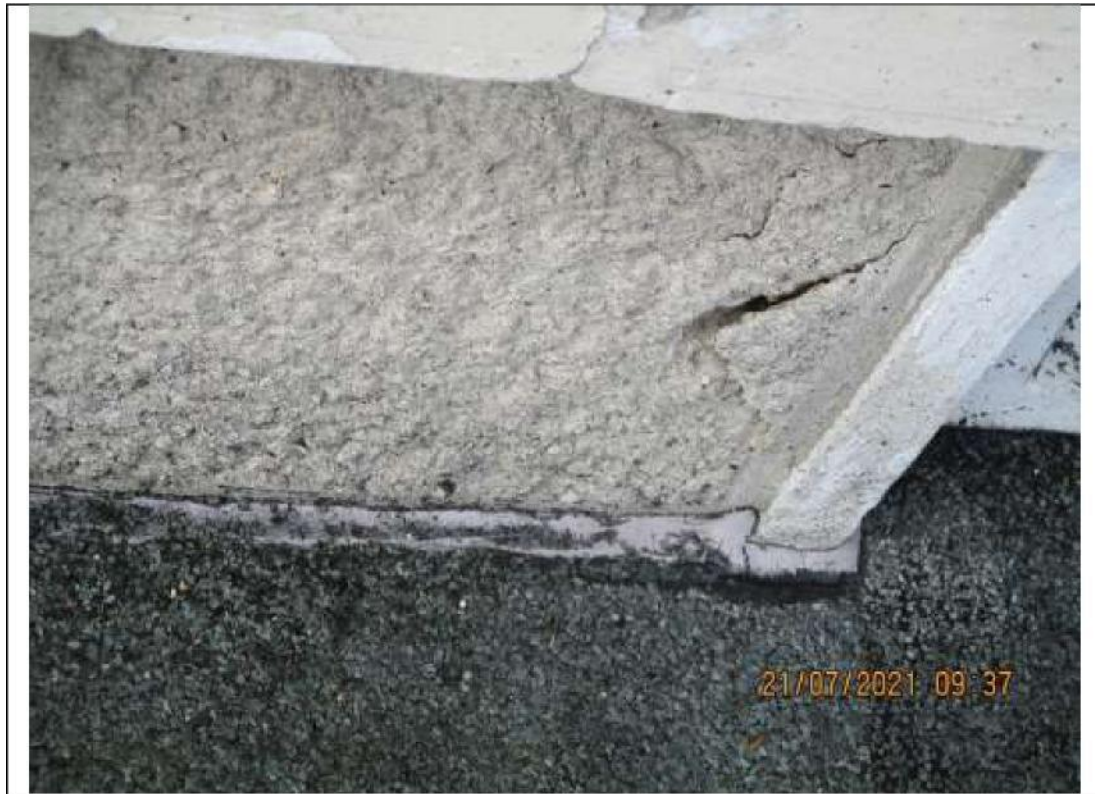
11) Cracked concrete adjacent to windows.

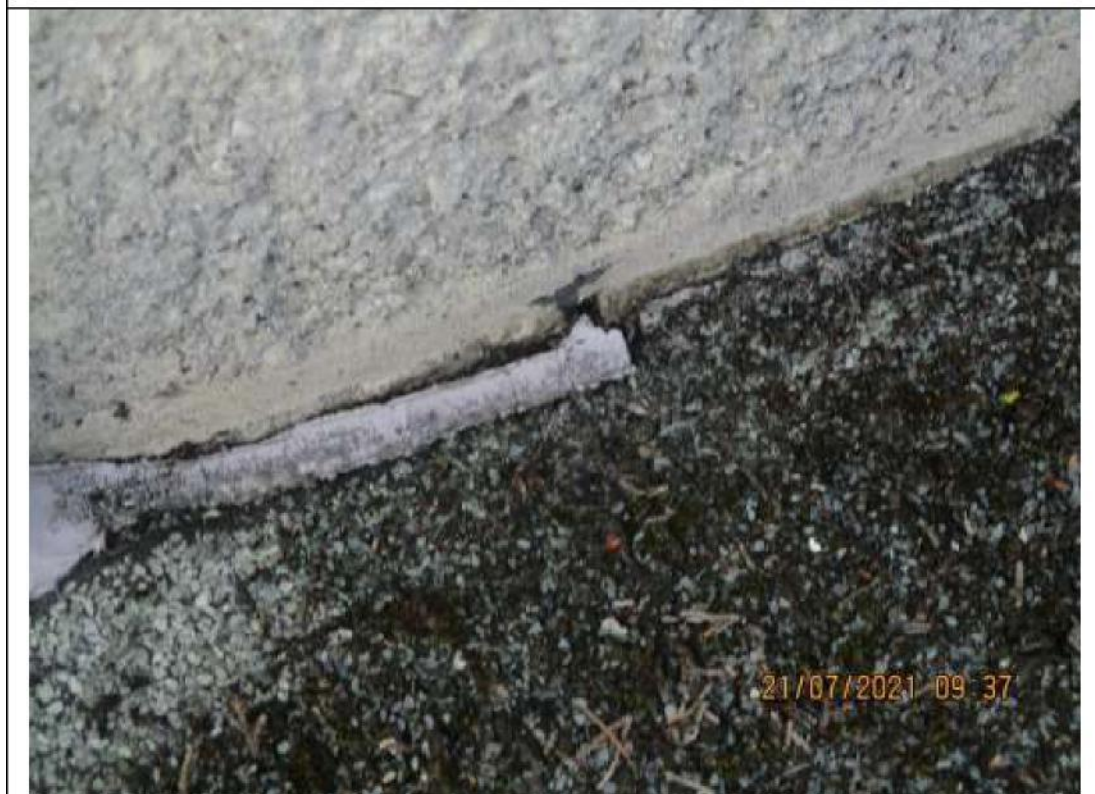
12) Defective mastic to joint of flat roof and window.

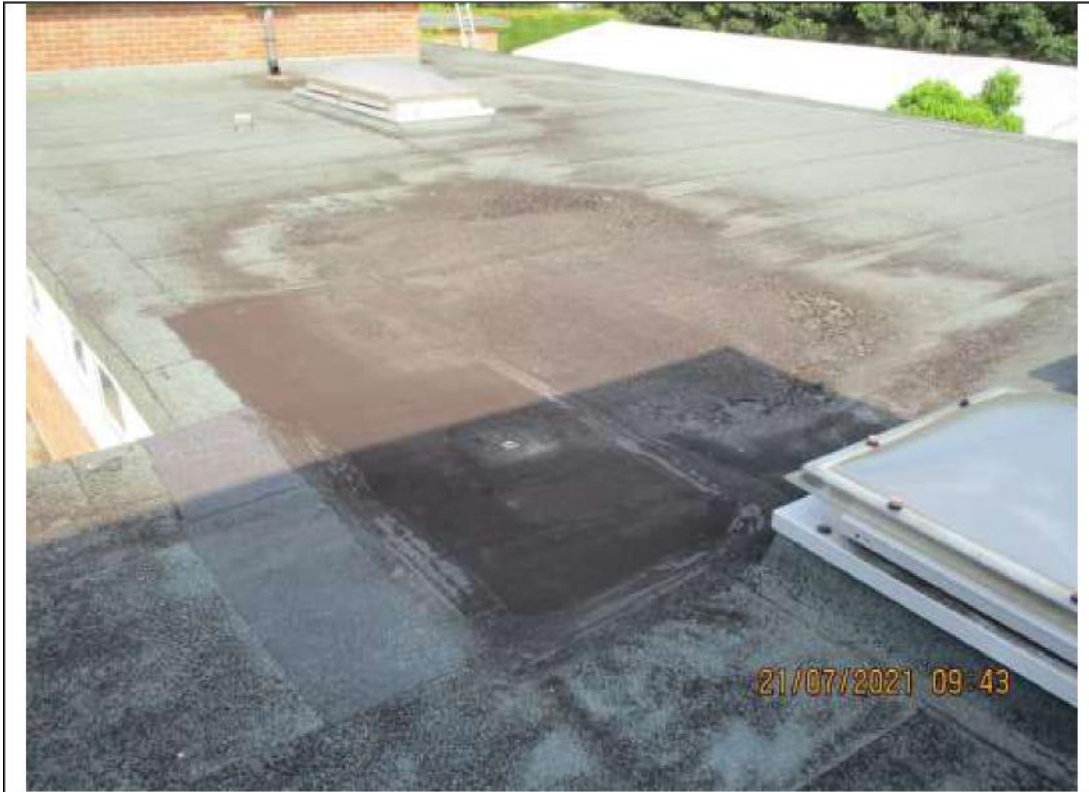
13) Patch repairs to flat roof area.

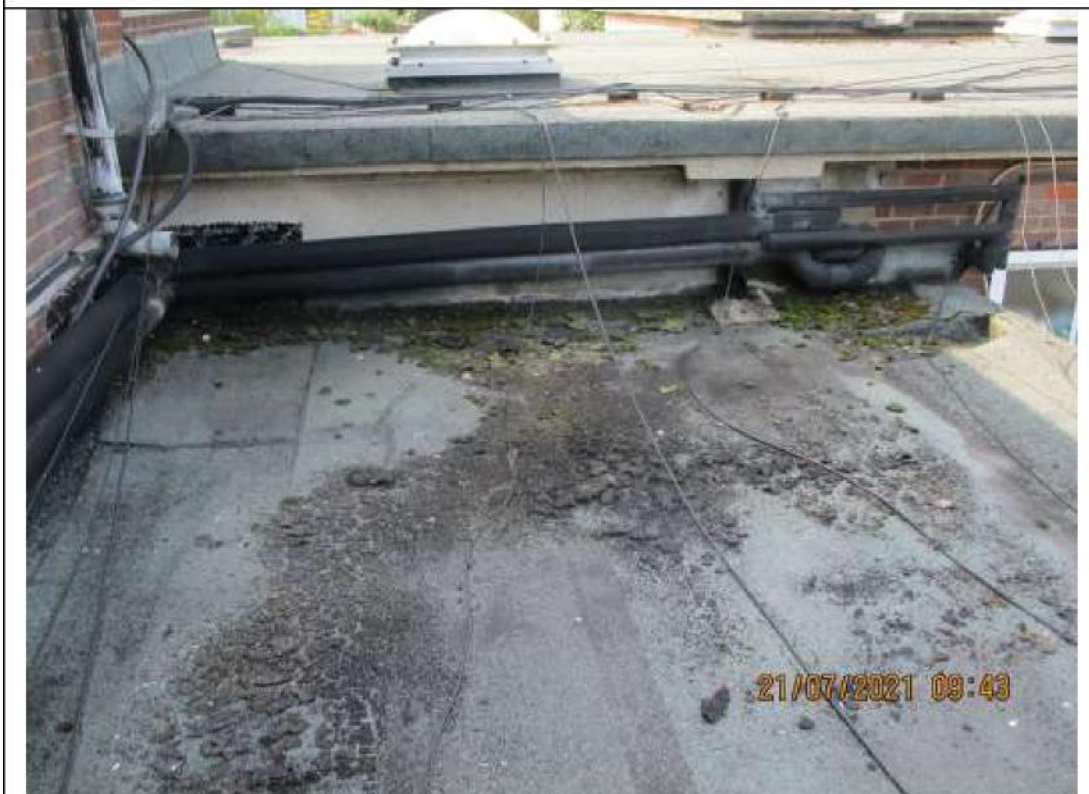
14) Evidence of surface water ponding to flat roof area.

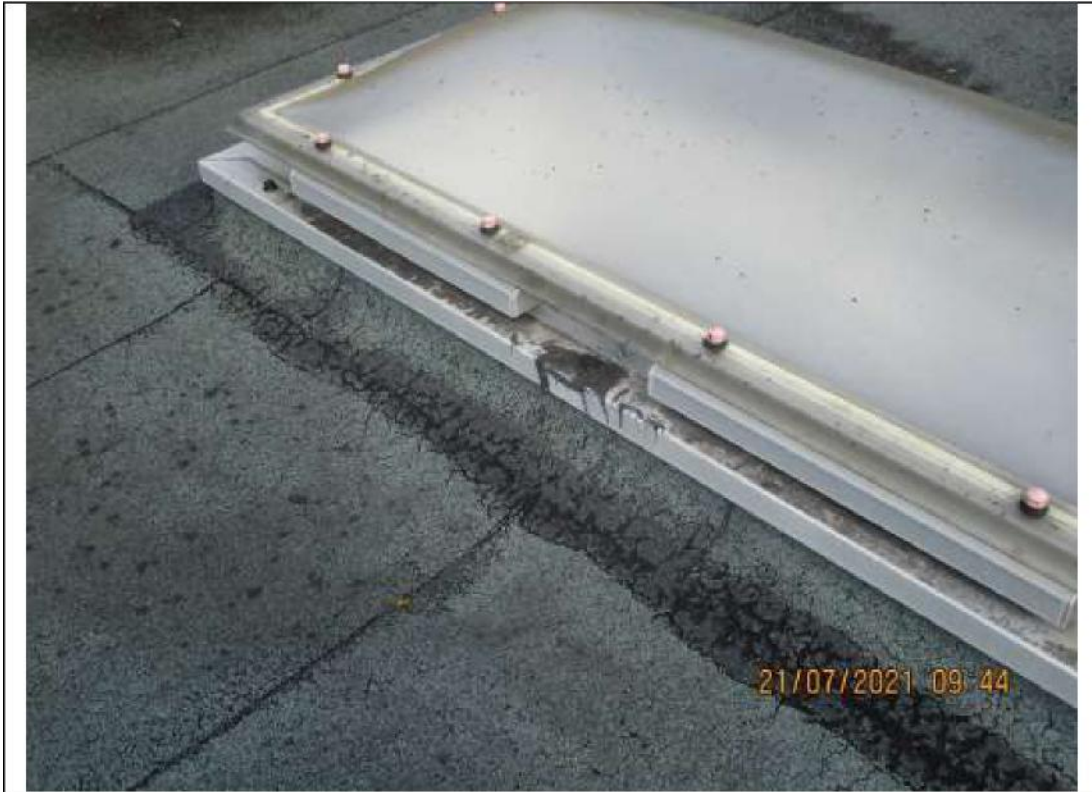
15) Patch temporary repairs to roof light upstand.

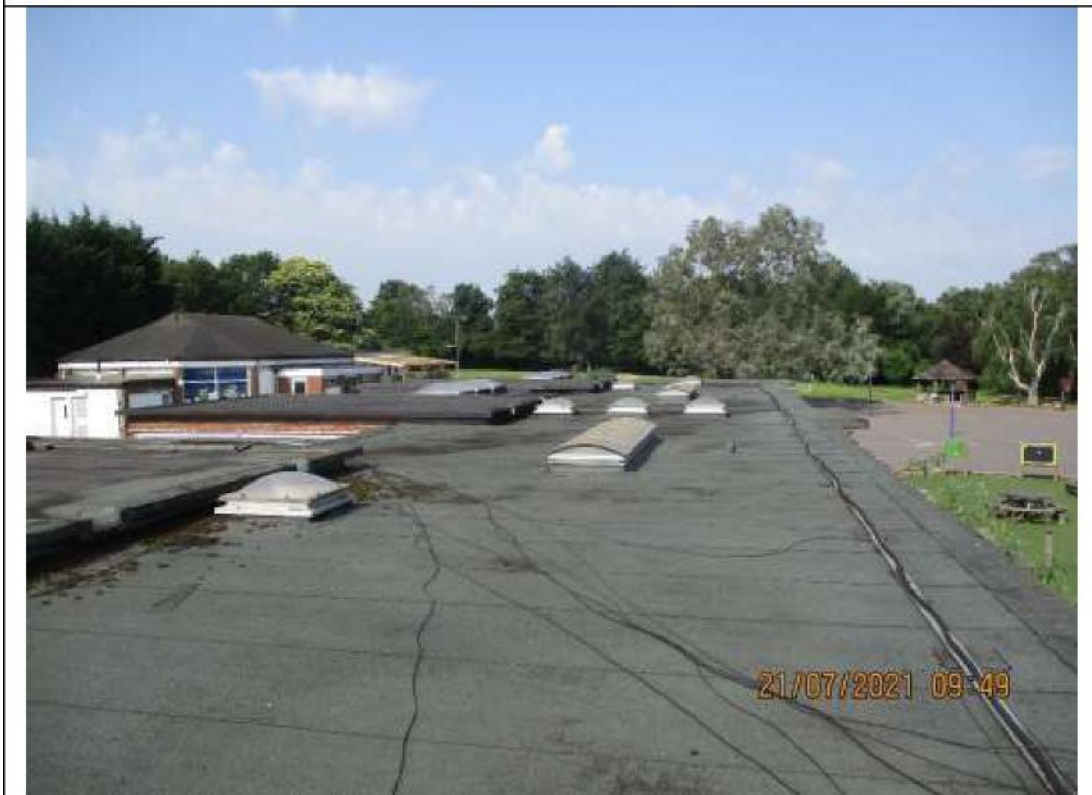
16) Roof above KS2 area.

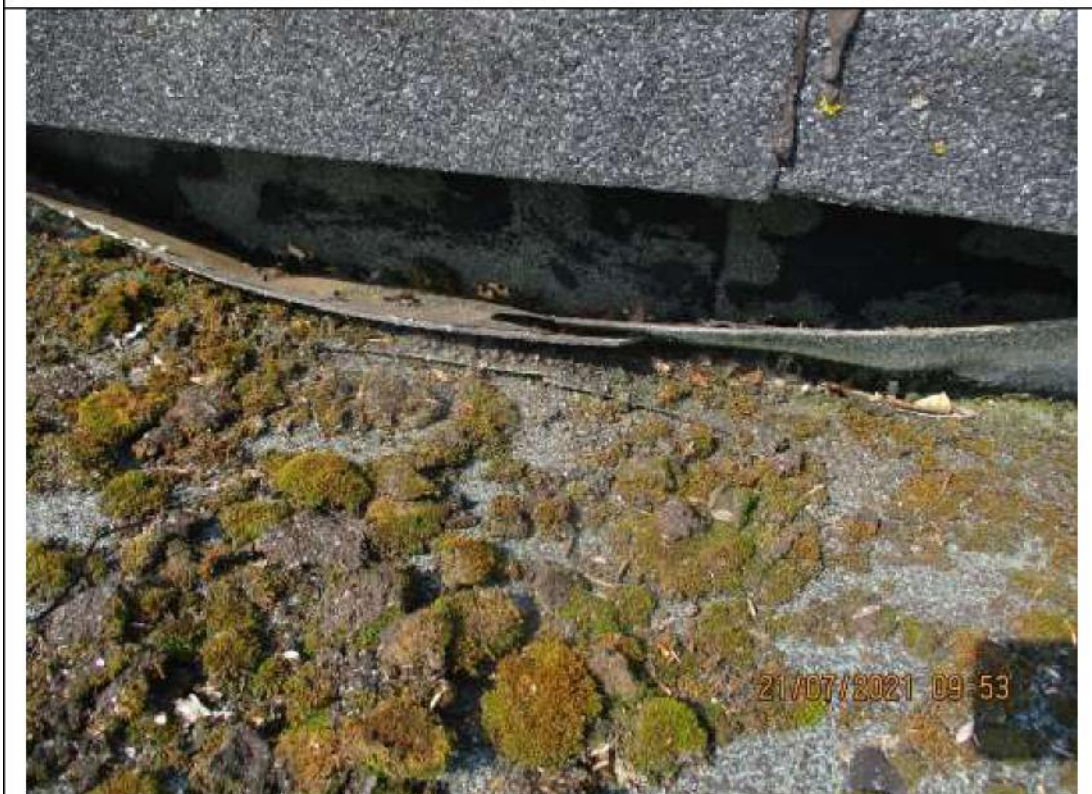
18) Defective felt upstand detail to roof above KS2 area.

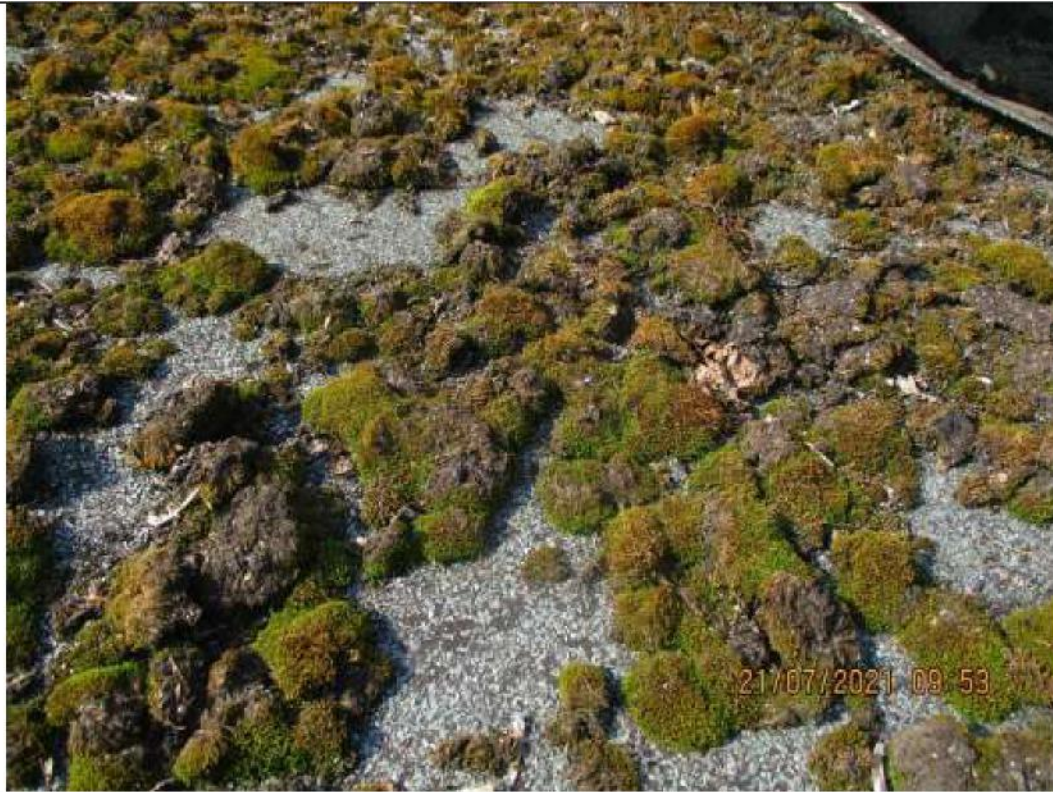
19) Build up of moss growth to flat roof.

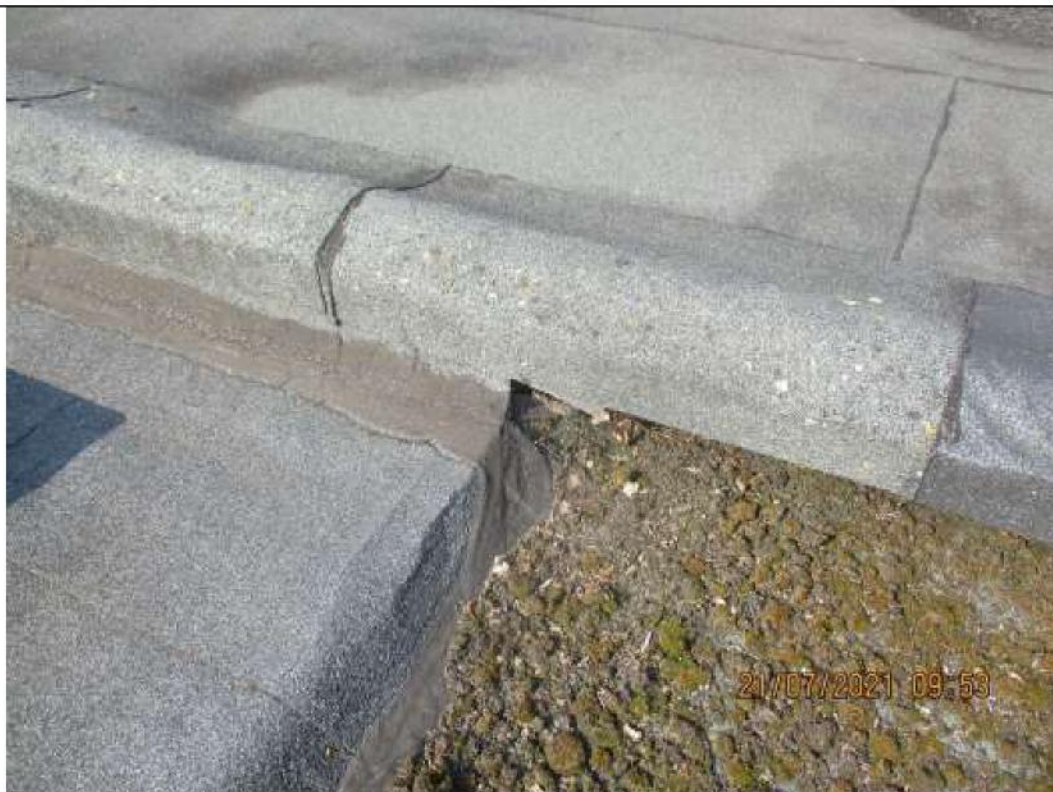
20) Patch repairs to roof above KS2 area.

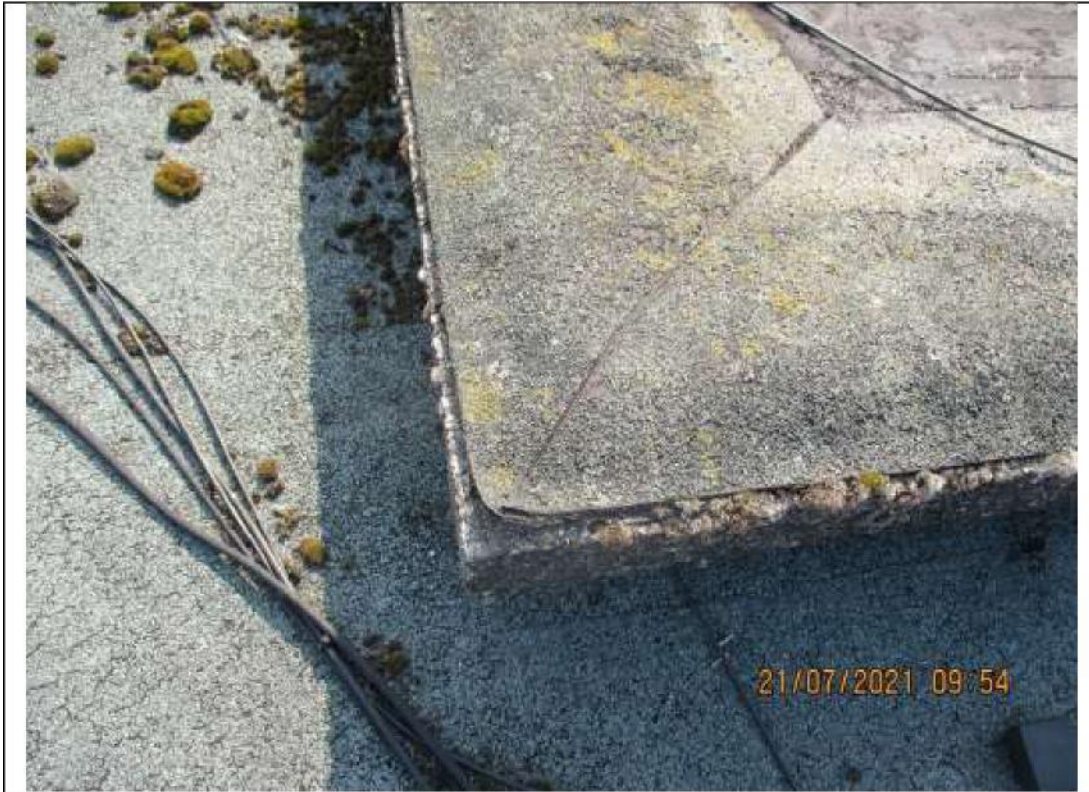
21) Patch repairs to roof above KS2 area.

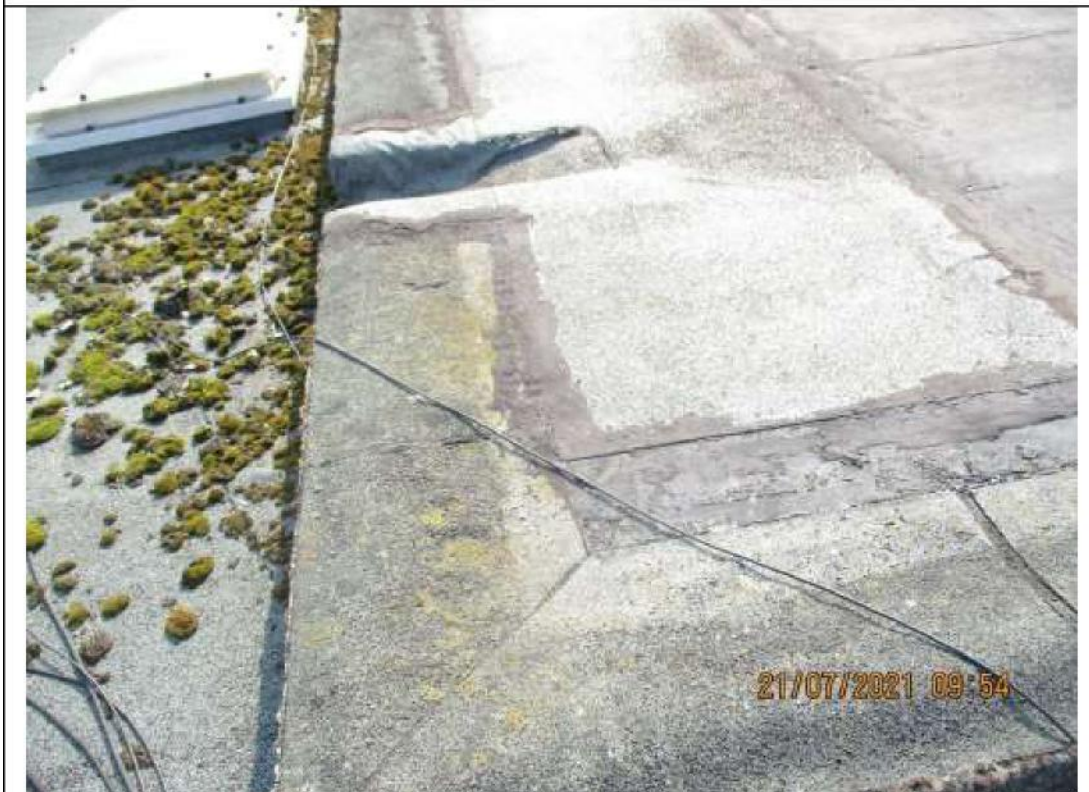
22) Patch repairs to roof above KS2 area.

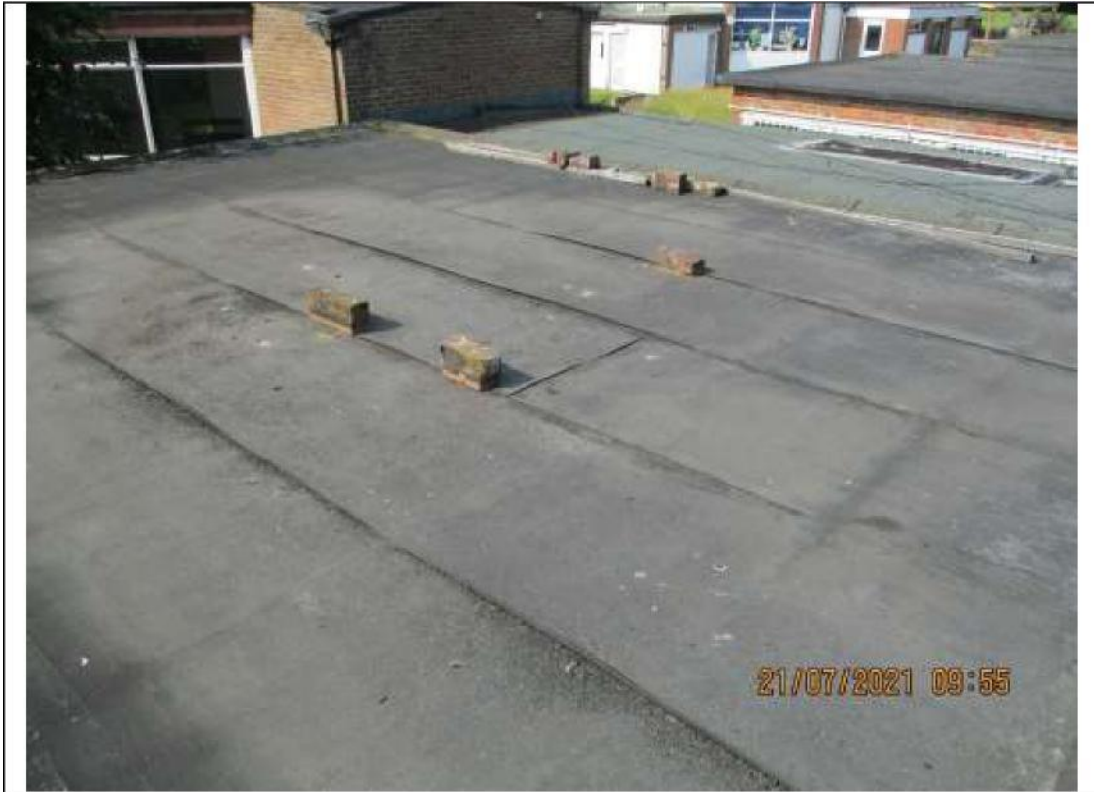
23) Patch repairs to roof above KS2 area.

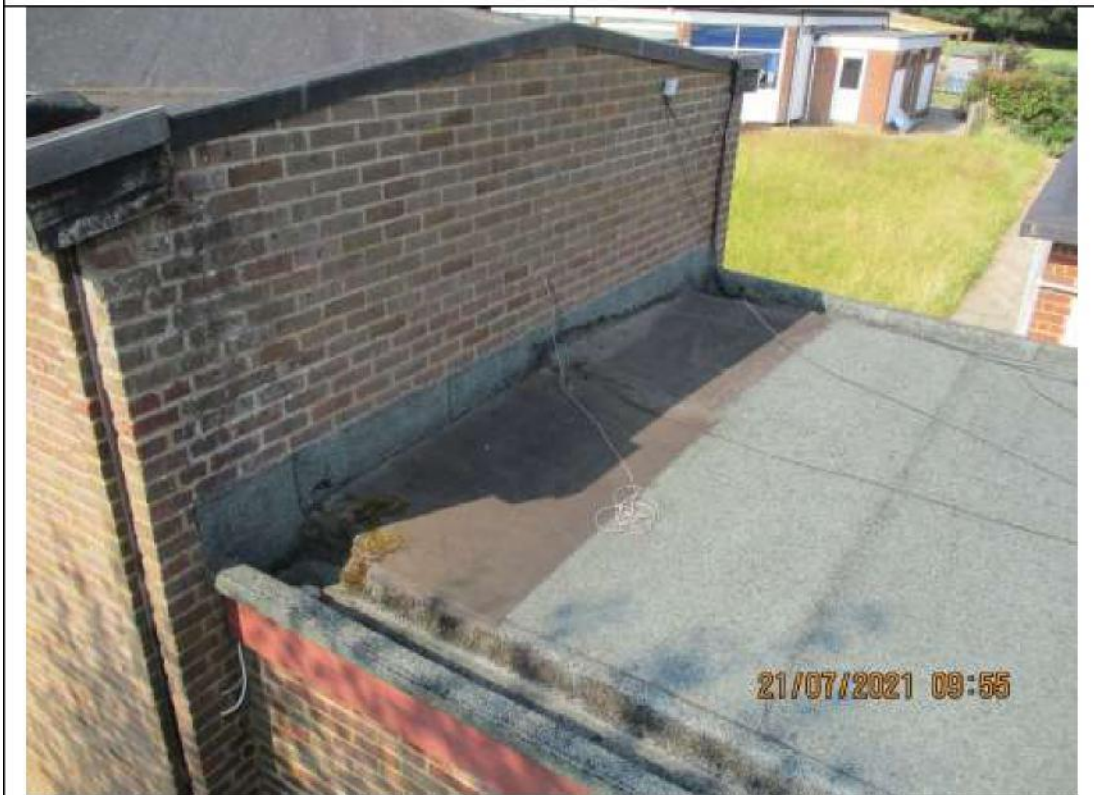
24) Link roof to gymnasium building.

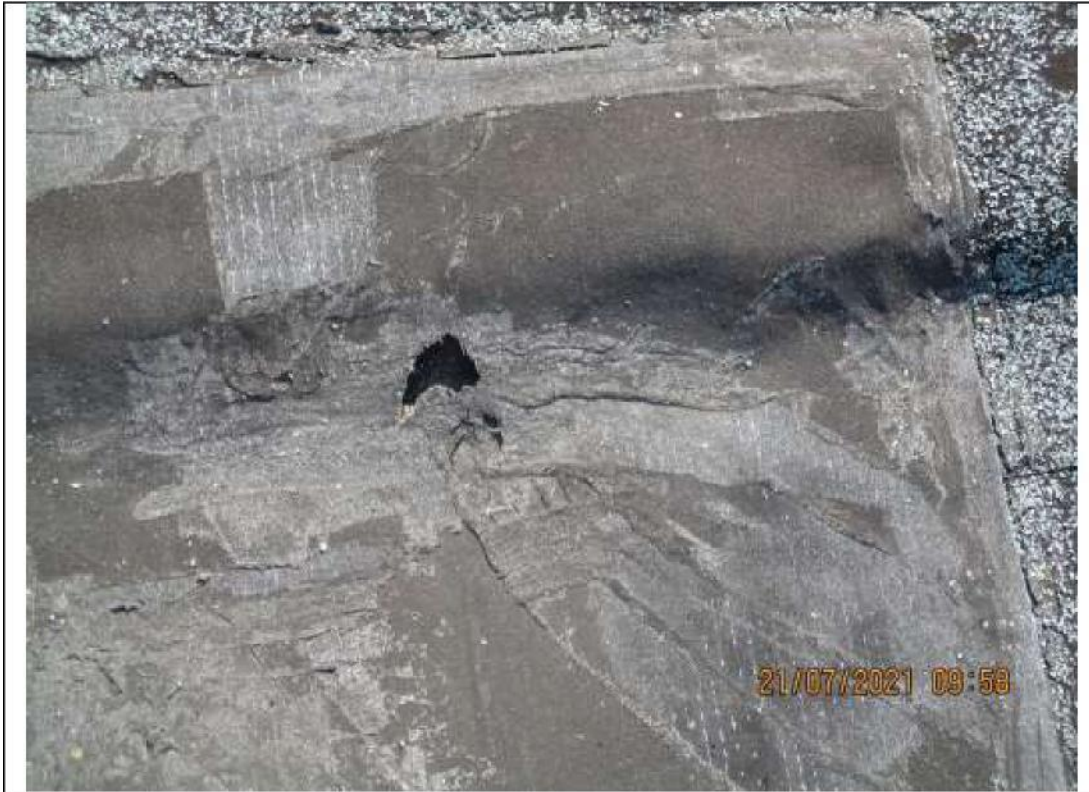
25) Failed patch repairs to link roof to gymnasium.

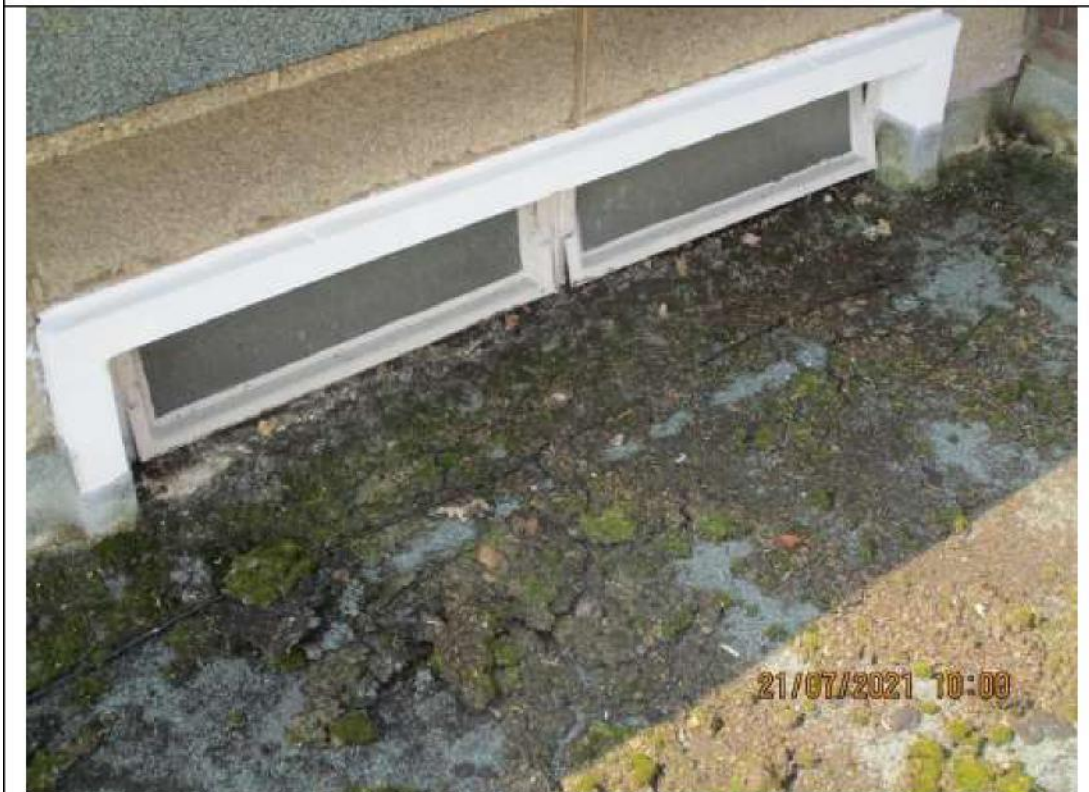
26) Low level windows to roof adjacent to the nursery.

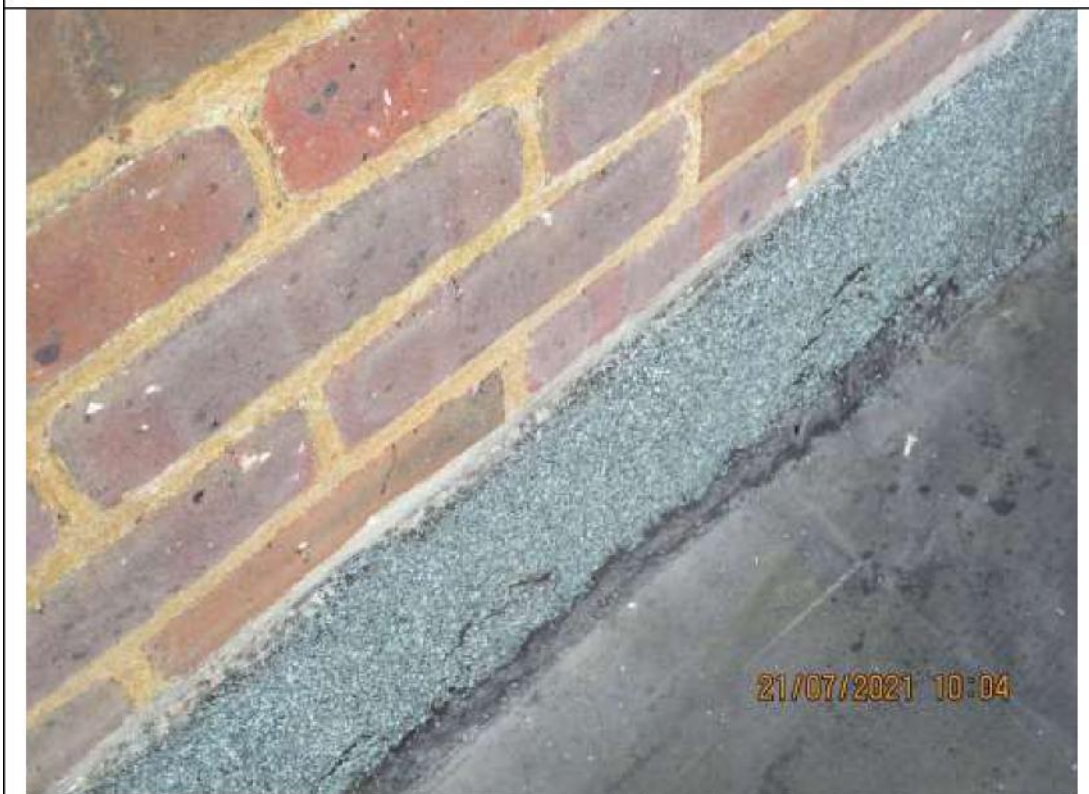
30) Defective upstand detail to link building to gymnasium.

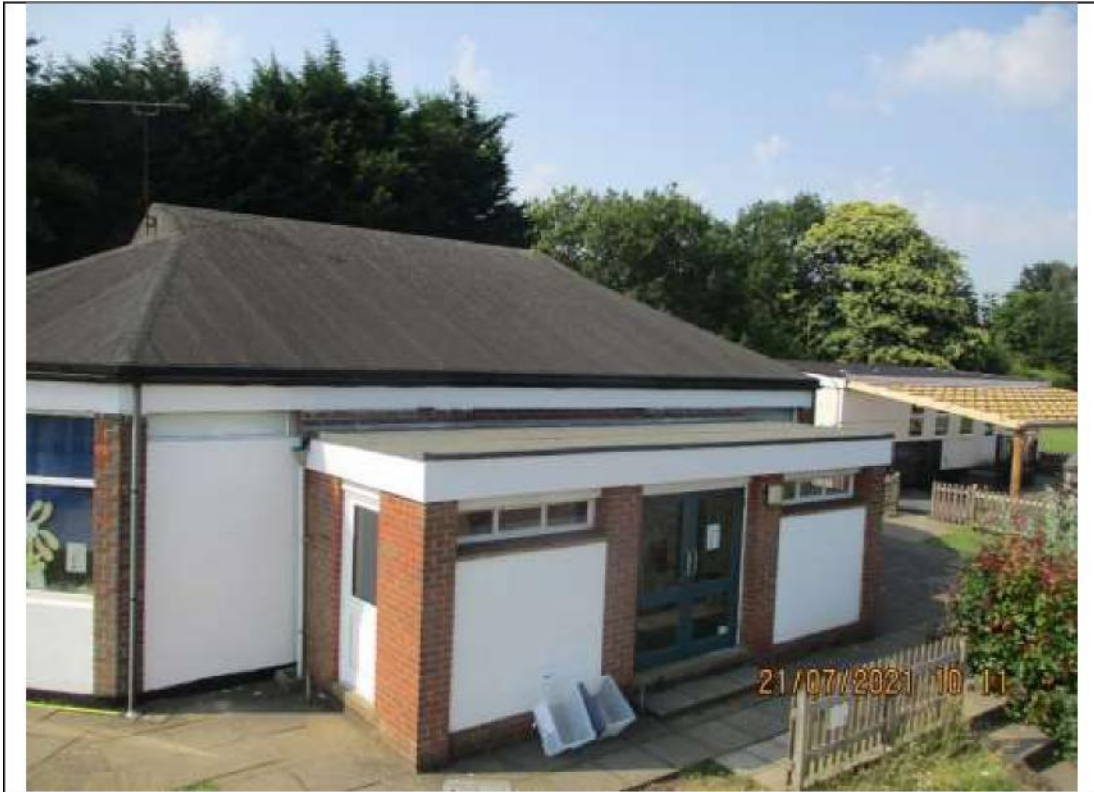
31) Roof above Year 5/6 block.

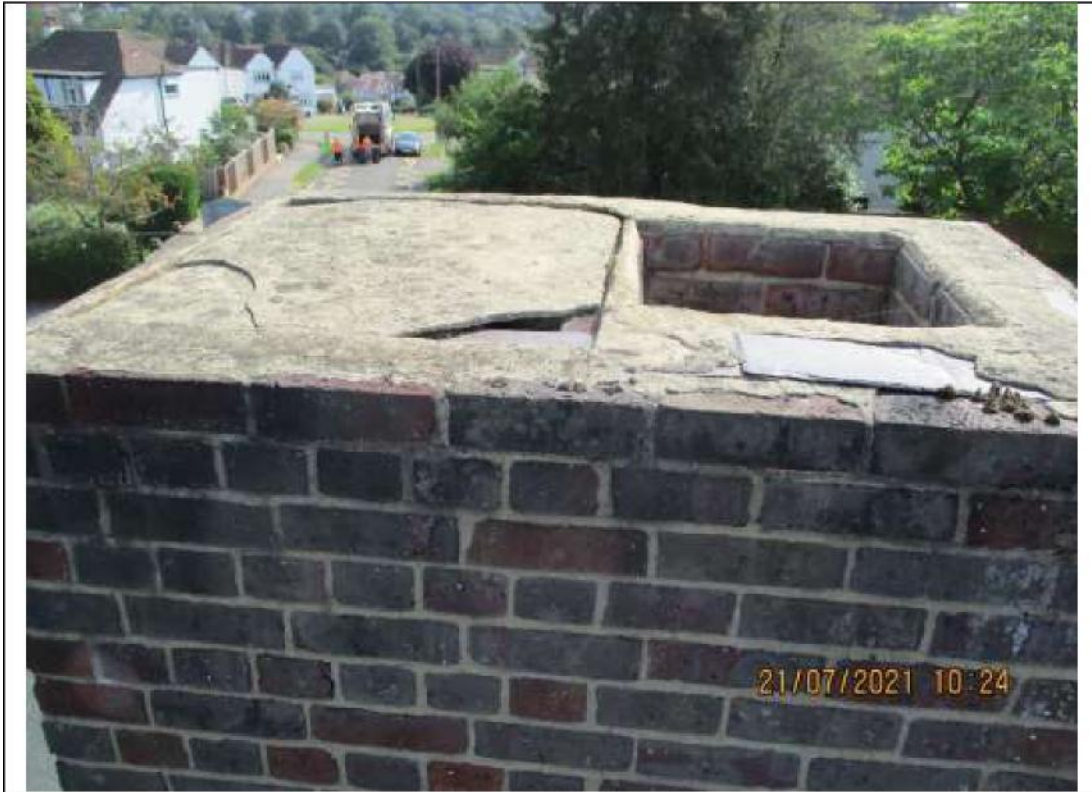
37) Defective stack capping to hall roof.

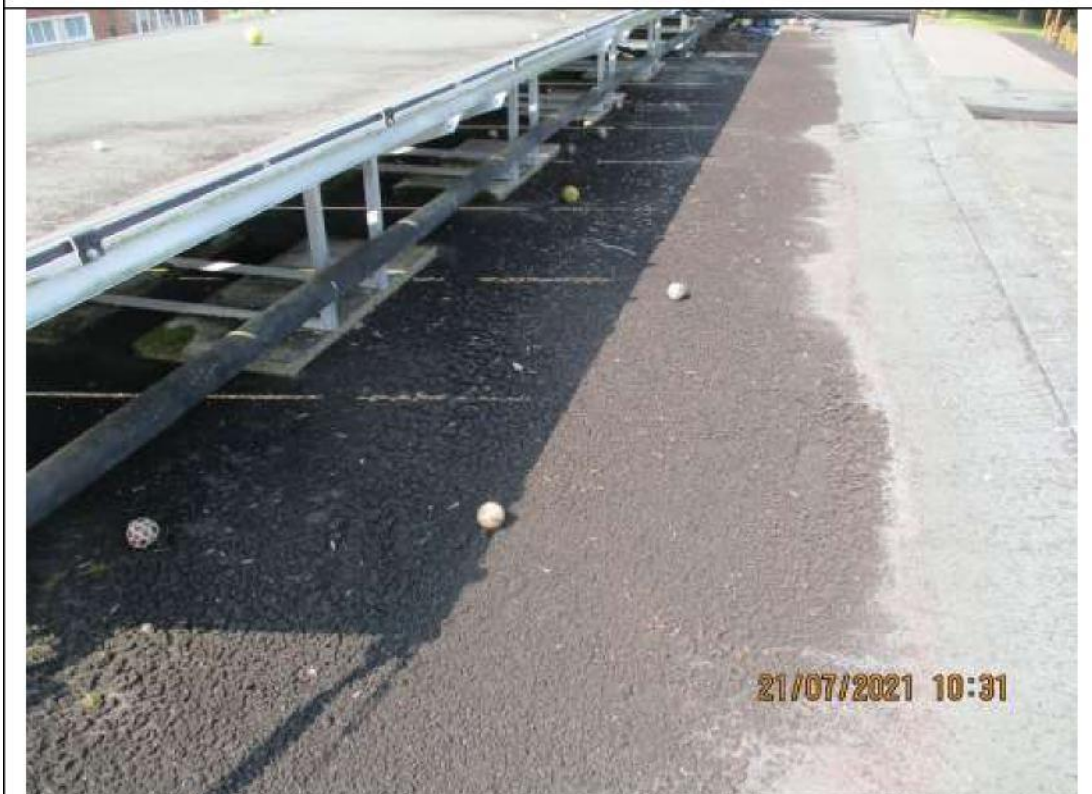
38) Higher level roof to KS1 area.

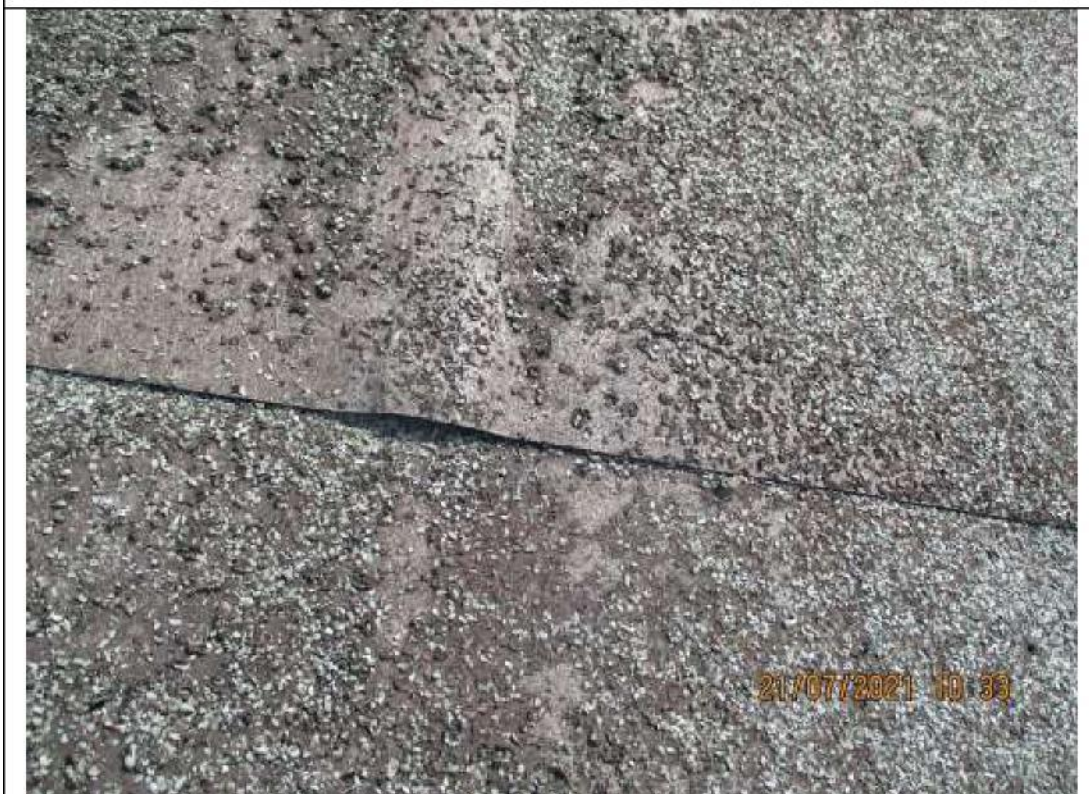
40) Defective/open laps to roof coverings.

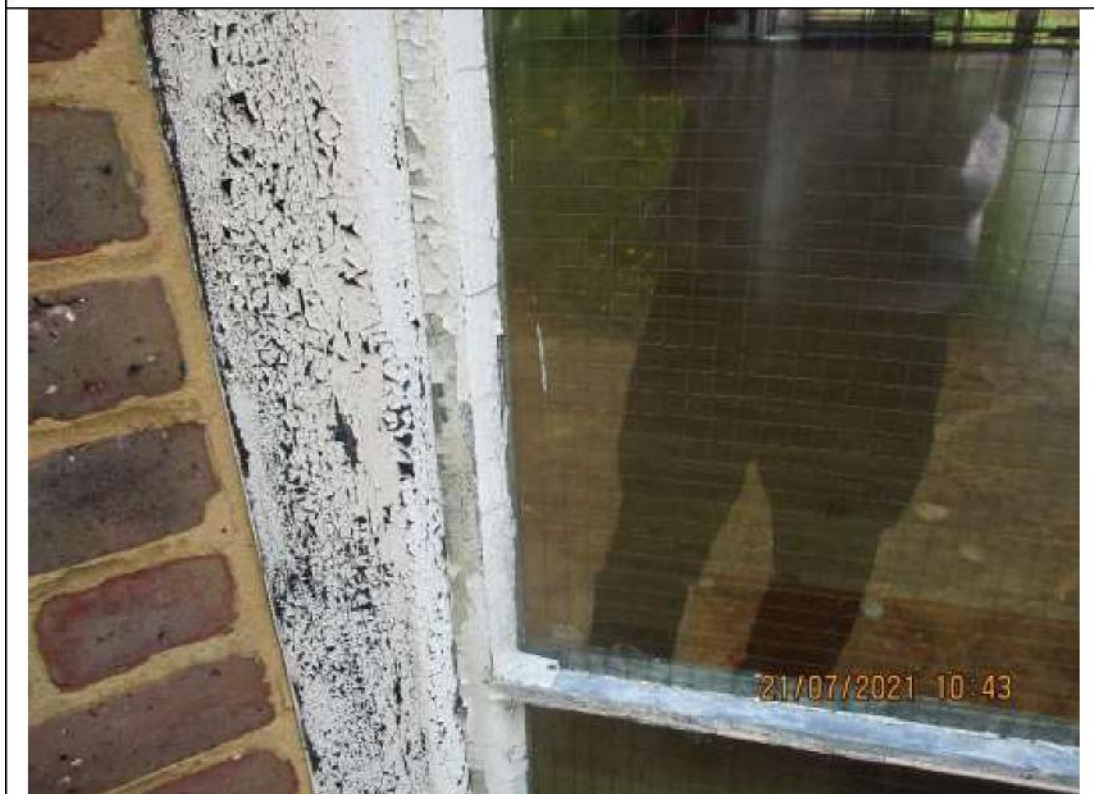
46) Typical defective paint finishes to original windows.

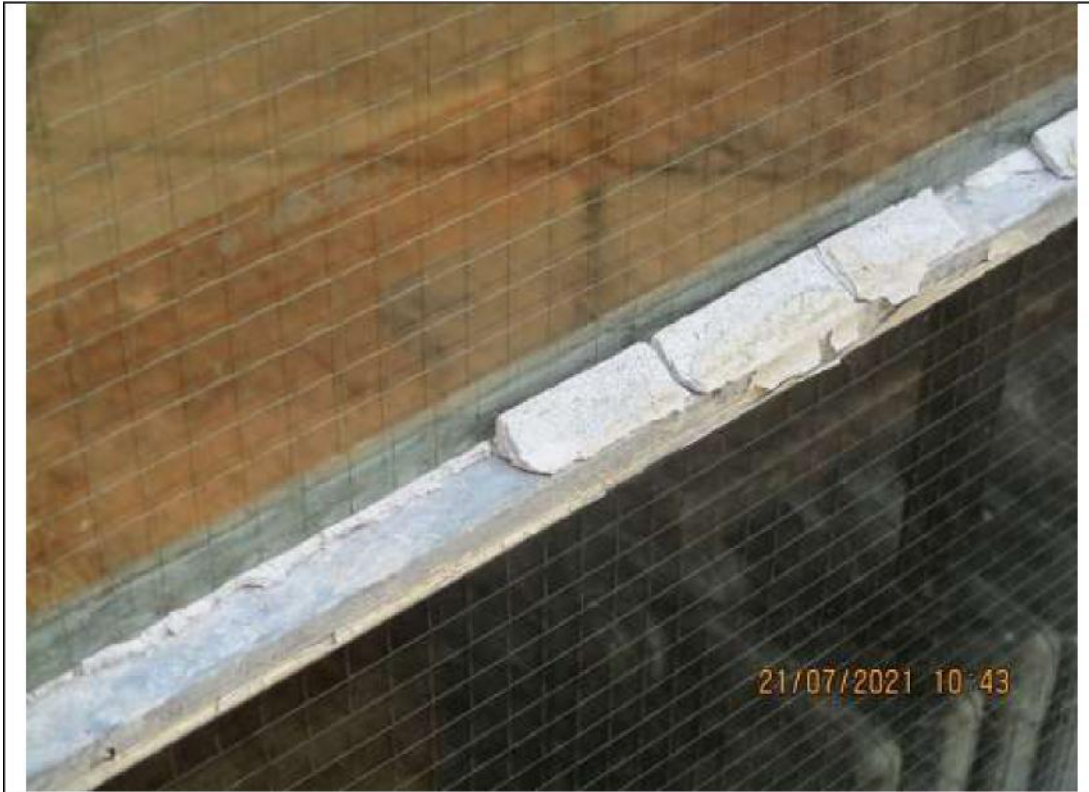
47) Typical cracked and defective window putties to original windows.

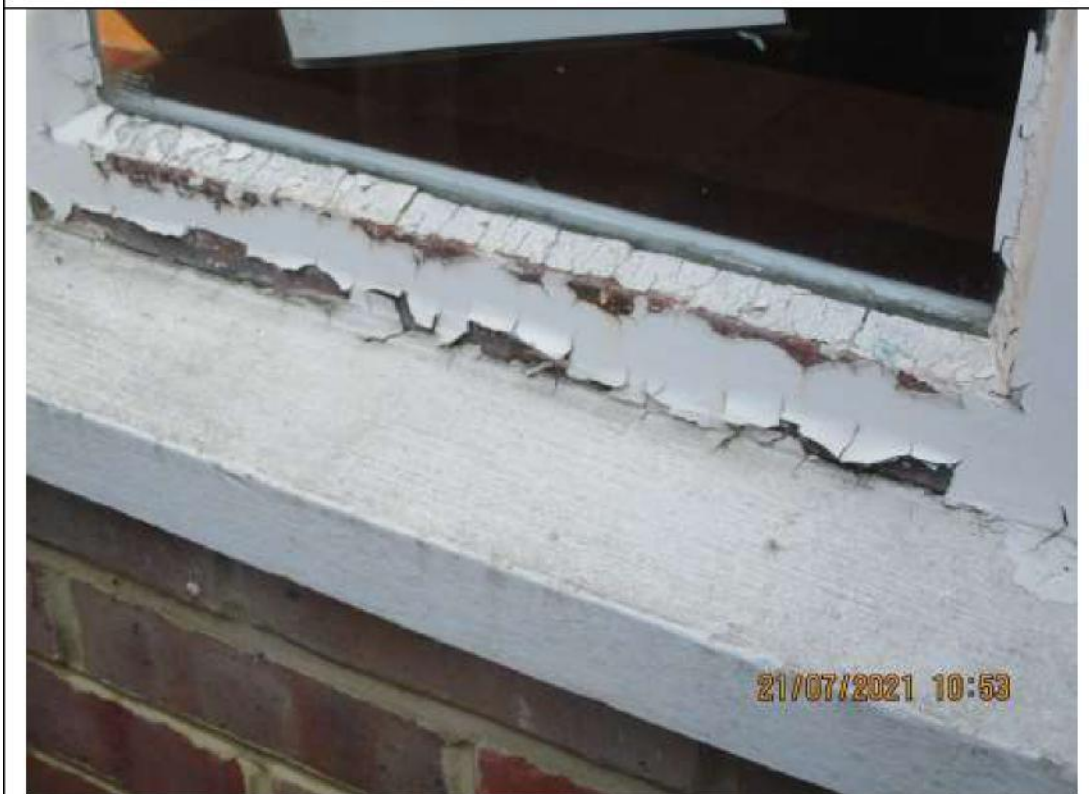
48) Typical flaking and missing paint to original windows.
