Condition Survey Report of Flat Roof Areas and Windows

[Redacted] School

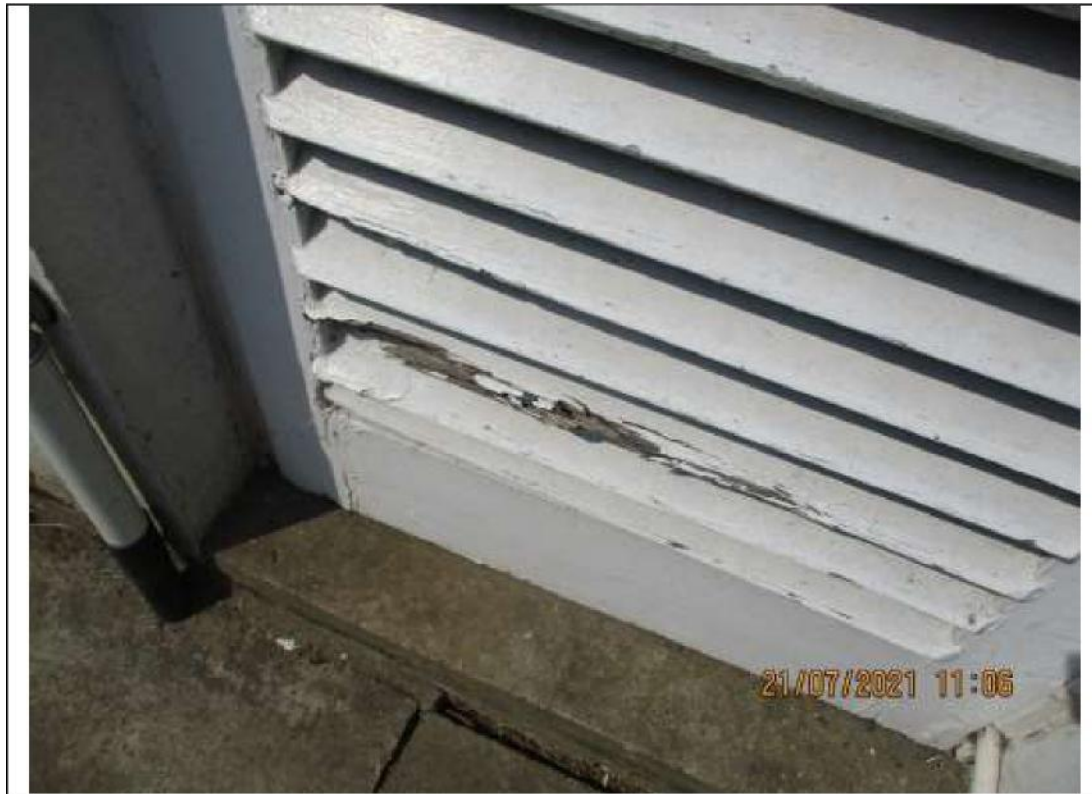
49) Rotten timber louvre door.

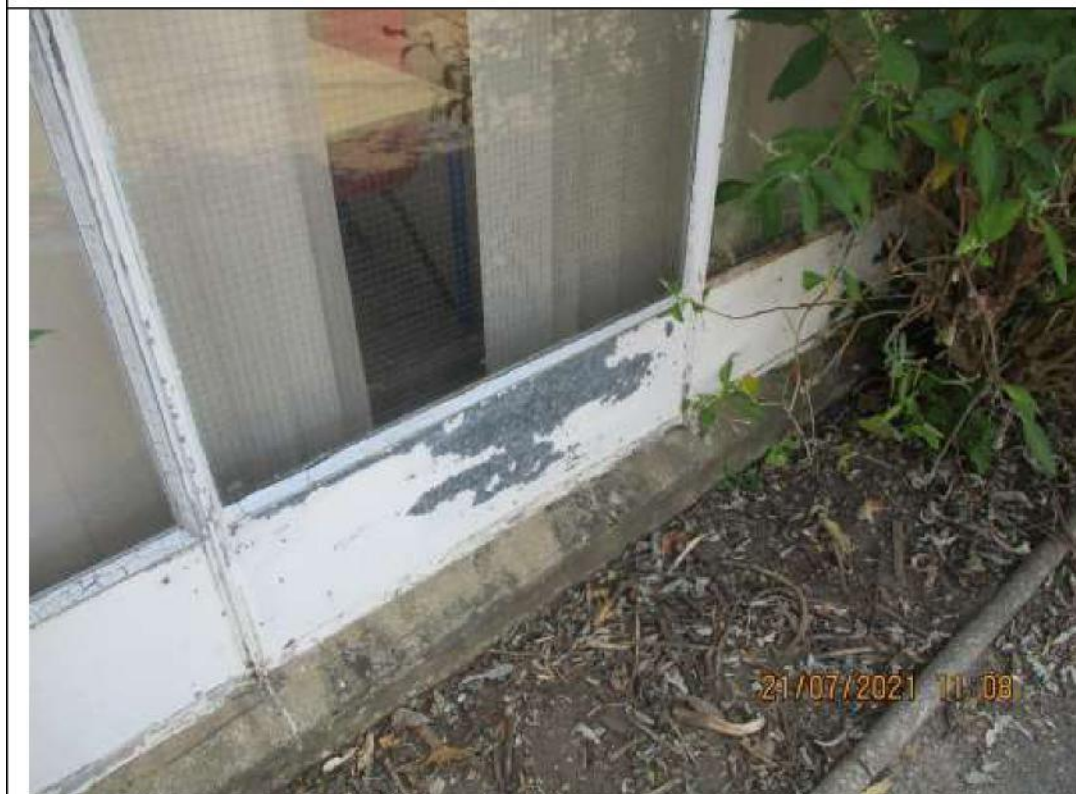
50) Typical flaking and missing paint to original metal door.

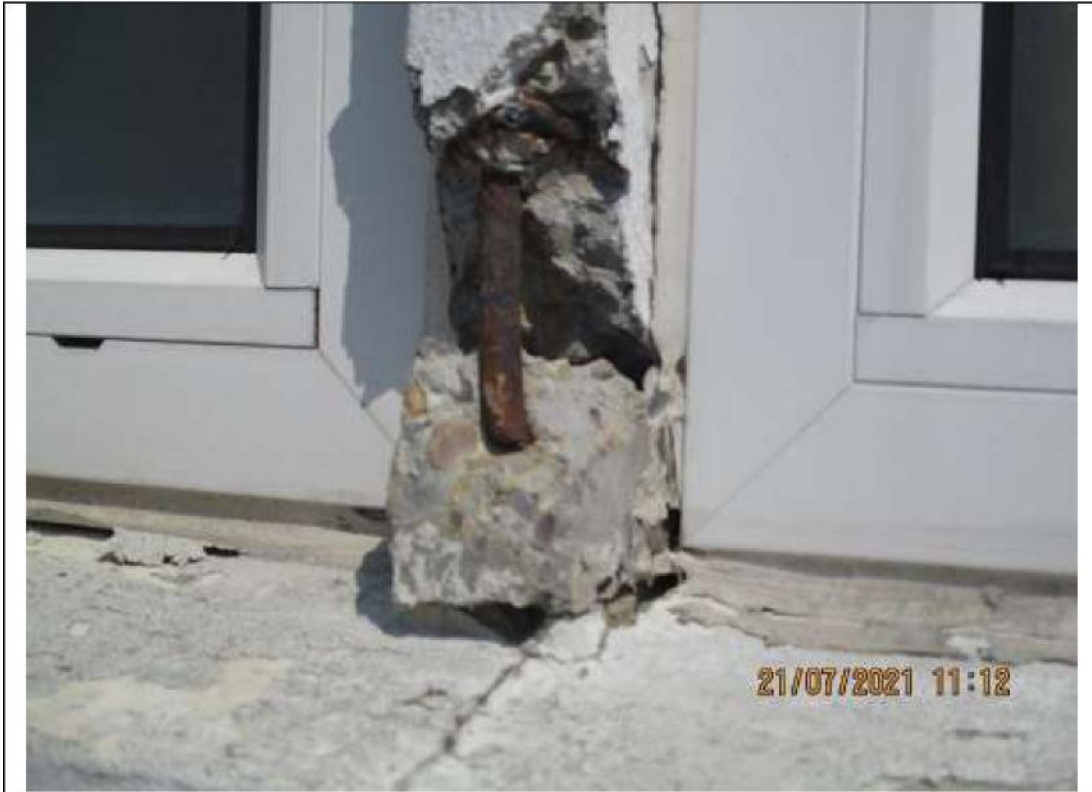
51) Example of defective concrete surround to windows.

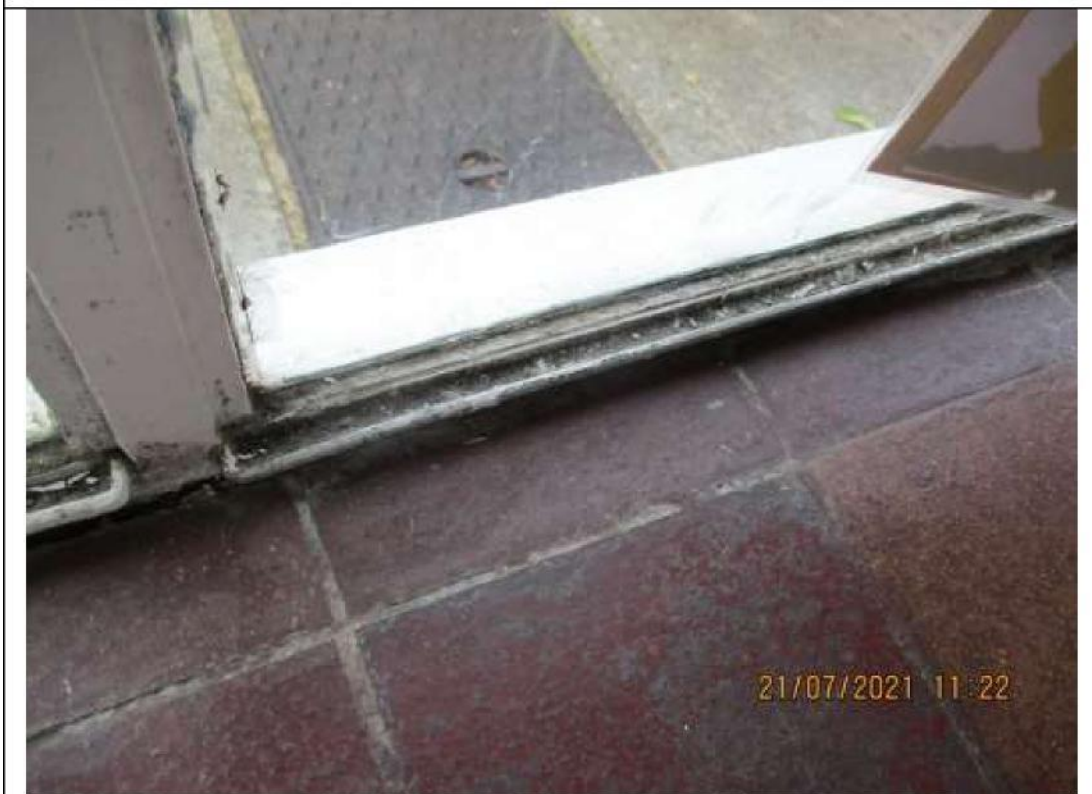
52) Example of internal condensation damp staining.

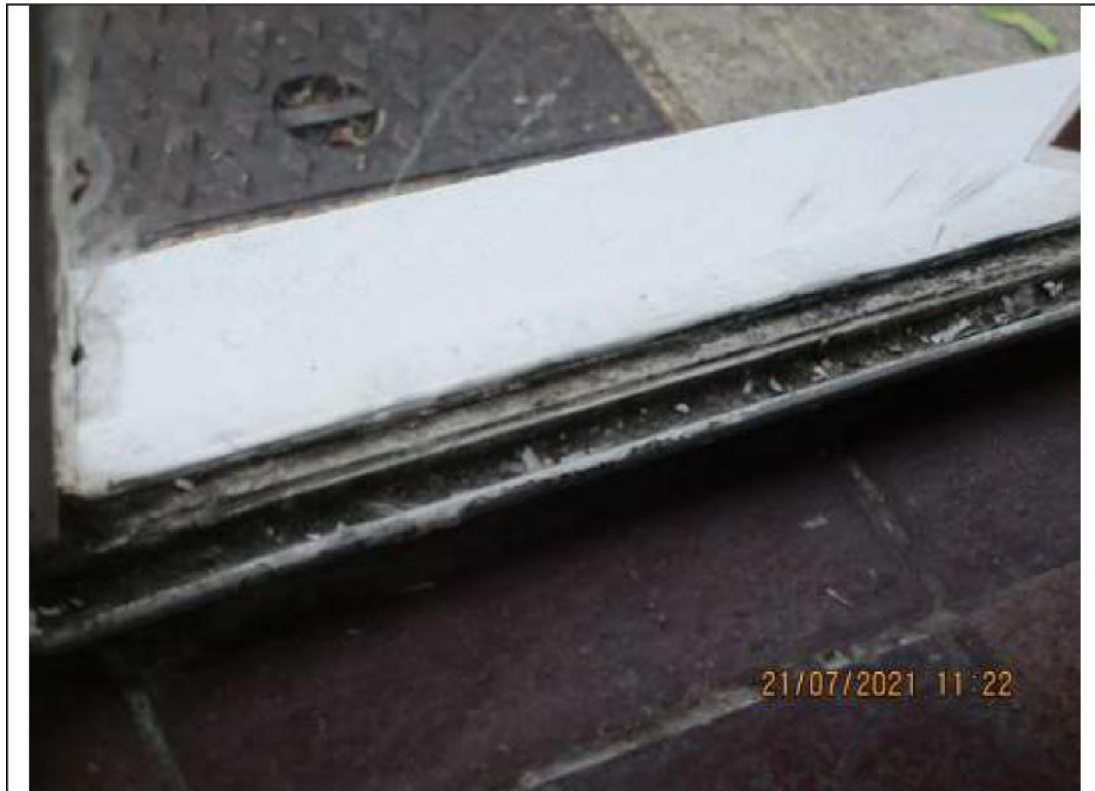
53) Example of internal condensation damp staining to original windows.

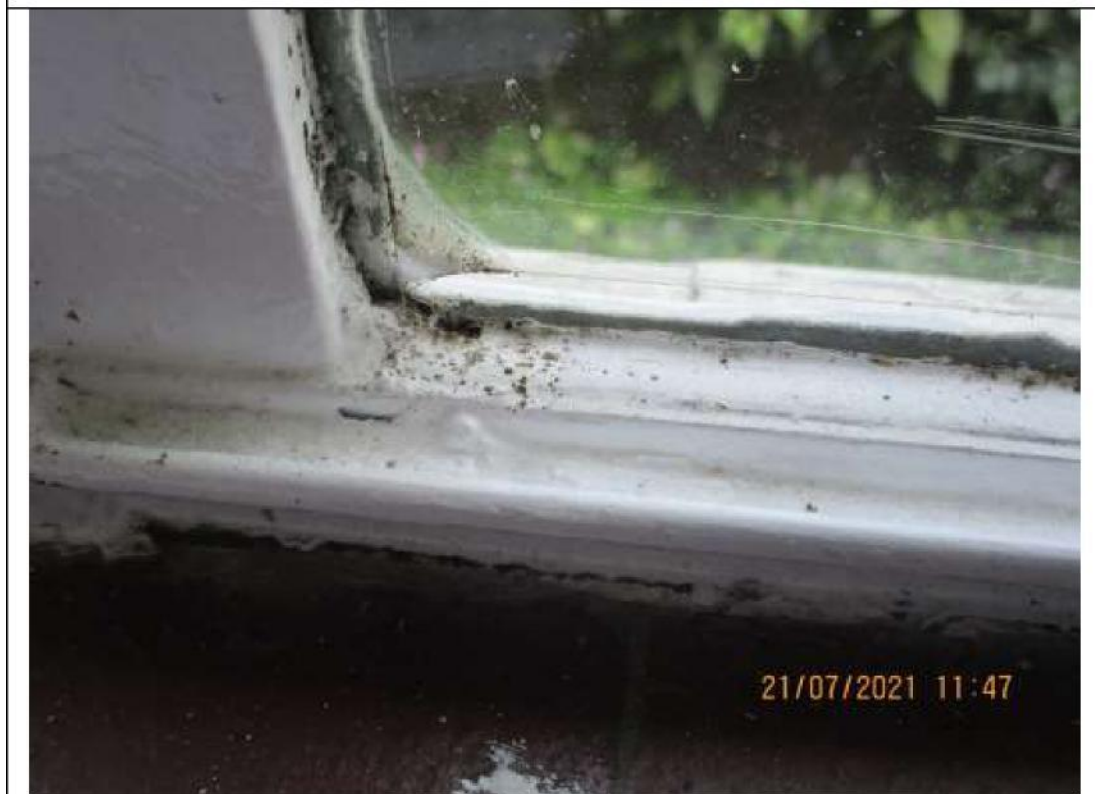
54) Example of mould growth to internal windows.
